## 2012–2013 Annual Report

### Environmental Impact Monitoring Program Ichthys On-Shore Liquefied Natural Gas (LNG) Facilities

Prepared for **JKC Australia LNG Pty Ltd** • July 2013

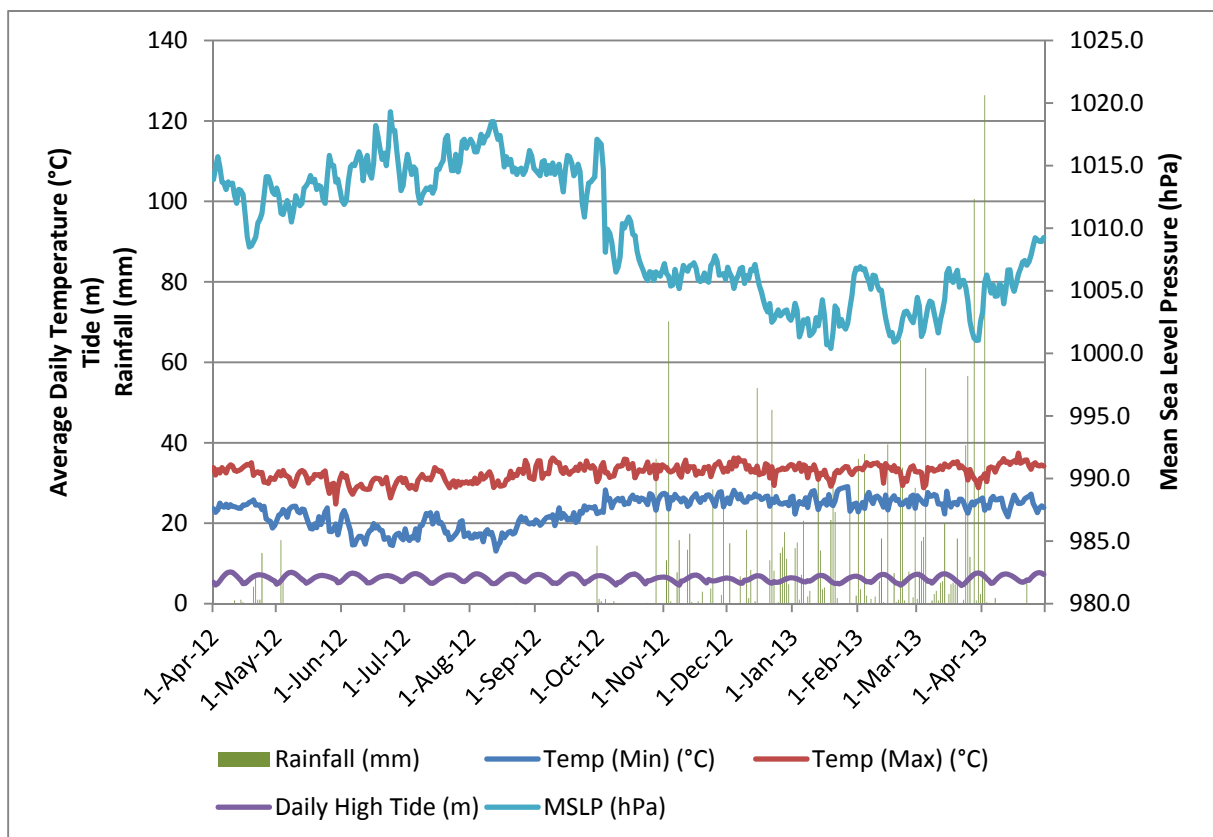
**Chart 3-1 Weather records of Darwin from 1 April 2012 to 30 April 2013 (BoM 2012 and URS 2012/13)**

**Chart 3-1** presents the climate data for the period 1 April 2012 to 30 April 2013. Meteorological data is presented in **Appendix A**. Tide Charts for 2012 and 2013 are included in **Appendix B**.

**Chart 3-1** is consistent with the tropical dry and wet seasons in the Darwin region, typified by:

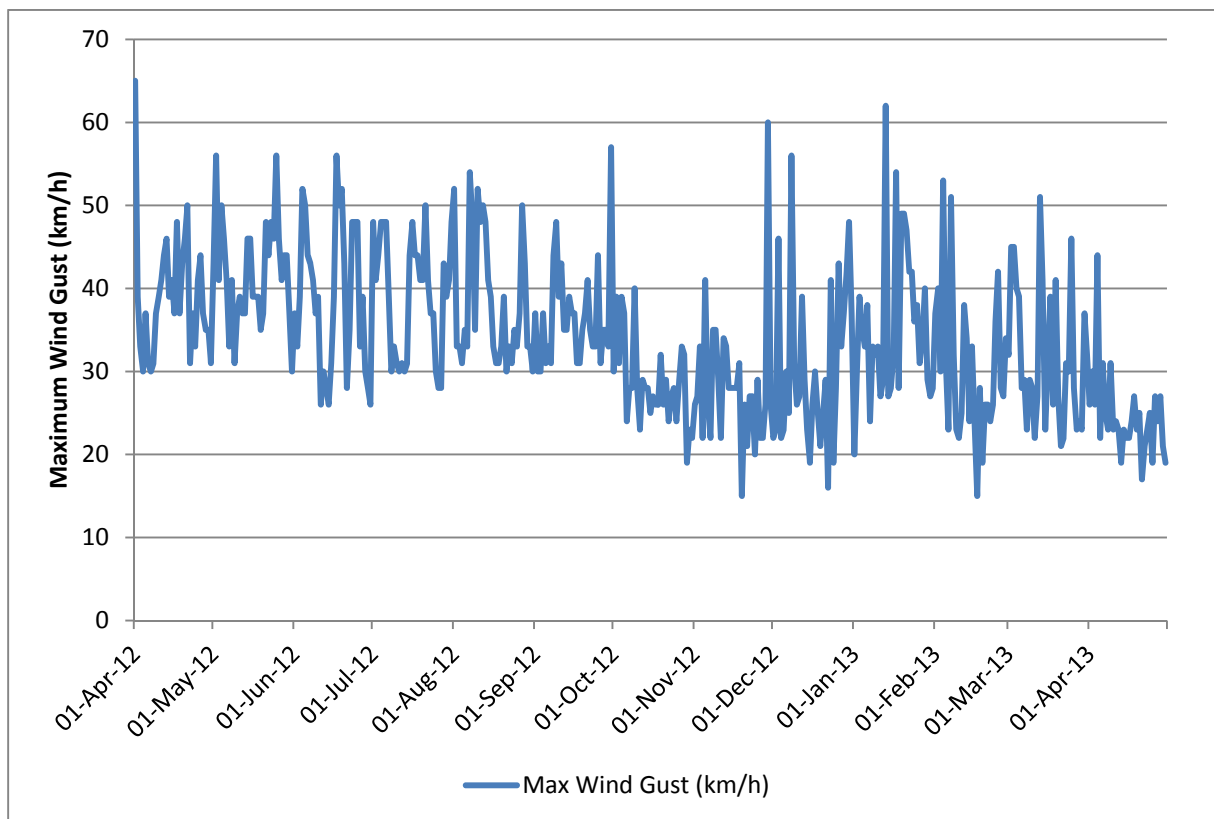
**Chart 3-4** Maximum wind gusts 1 April 2012 – 30 April 2013 (BoM 2012 and URS 2012/13)

The site experienced dry, gusty conditions throughout the dry season. The wet season wind speeds whilst lower than the dry season were gusty also. **Chart 3-4** illustrates the maximum wind gusts recorded in Darwin and on site.

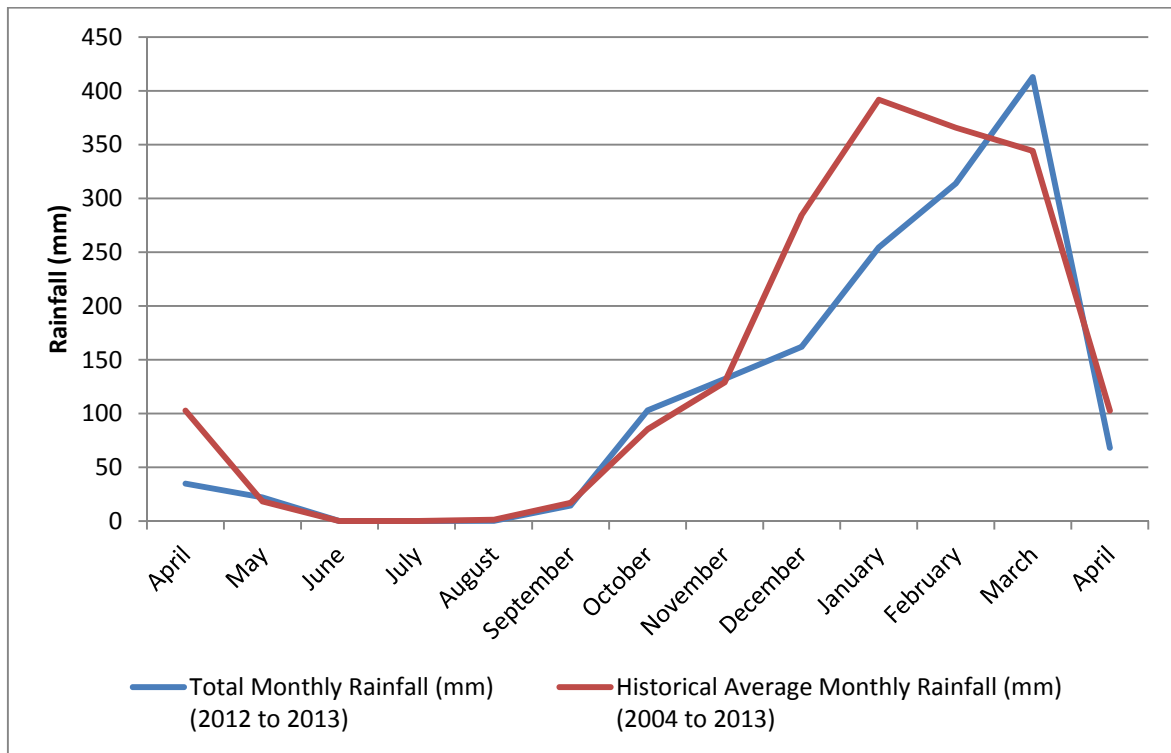
**Chart 3-6** 2012/13 Total monthly rainfall and Historical average monthly rainfall for Palmerston BoM station (BoM, 2013)

**Chart 3-6** presents the total monthly rainfall recorded in 2012/13 against the historical average monthly rainfall recorded between 2004 and 2013 at The Chase, Palmerston BoM station. **Chart 3-6** shows that overall Palmerston received average rainfall for the Darwin region.

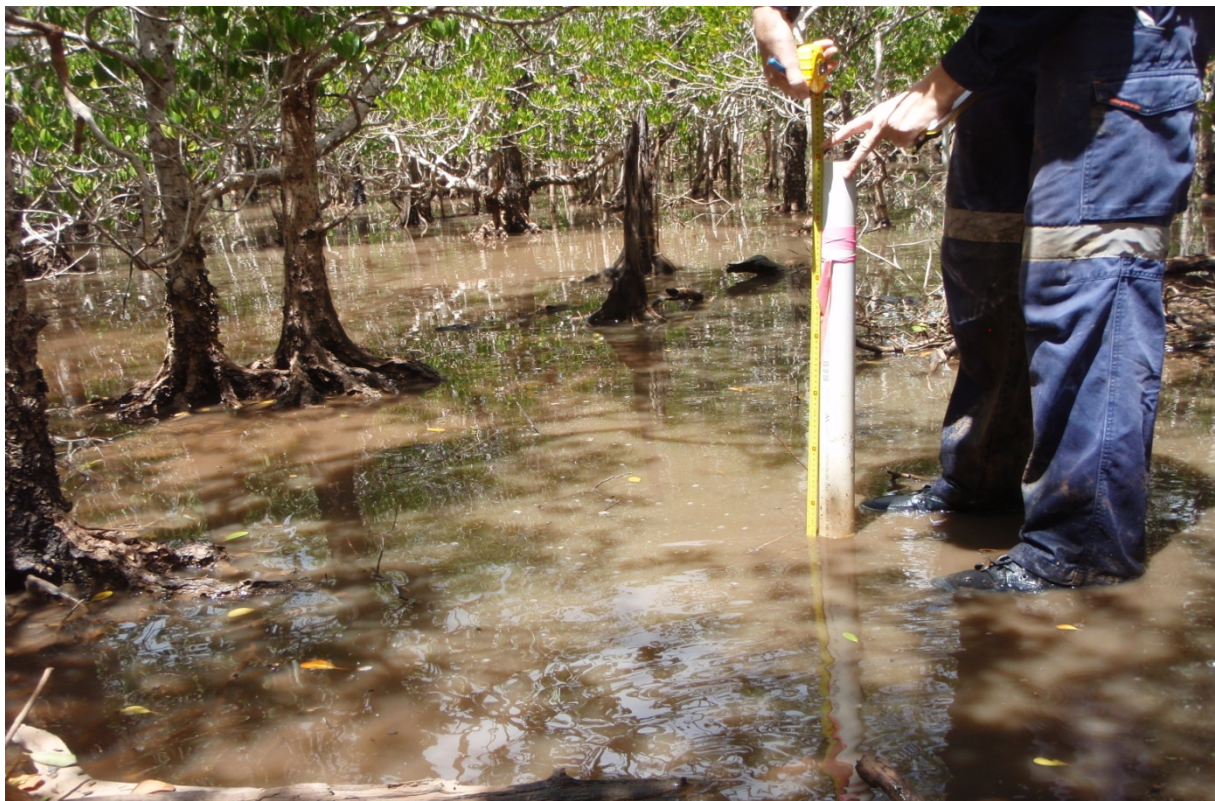
- At the monitoring site BPMC7 (located between survey points 7003 and 7004 - see **Figure C4**) ponding of approximately 5 cm depth was noted (see **Plate 6-1**). The mangrove health data recorded from this site in March 2013 indicates there had not yet been any deterioration in mangrove health from the ponding (see **Table 6-3** and **Table 6-4**); and
- The area of ponding includes mangrove areas outside of the CWA boundary and, on the basis of a similar ponding effect observed adjacent to Area 11A, it is possible that the mangrove mortality will extend to mangrove areas outside of the site boundary.

**Plate 6-1** Ponding of tidal waters amongst *Ceriops australis* mangroves at Site BPMC7 in March 2013

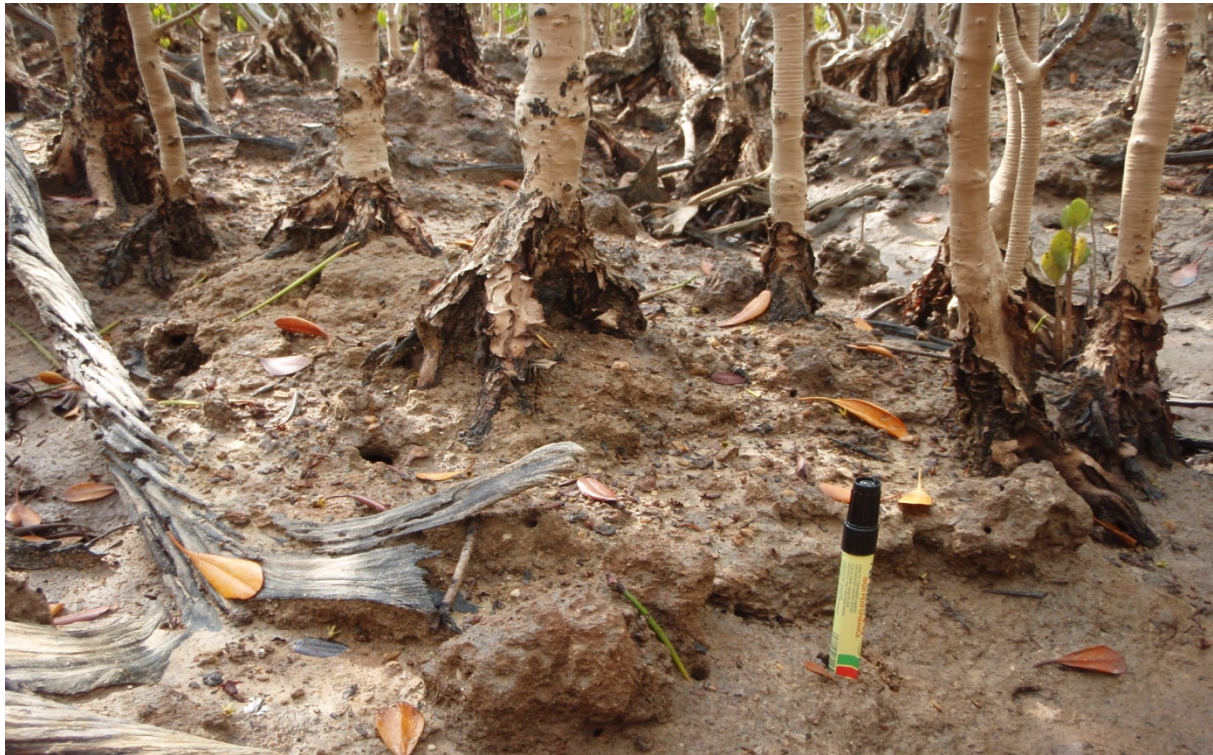
**Plate 6-2** Typical view of the variation in ground surface levels within mangroves due to bioturbation and root structures

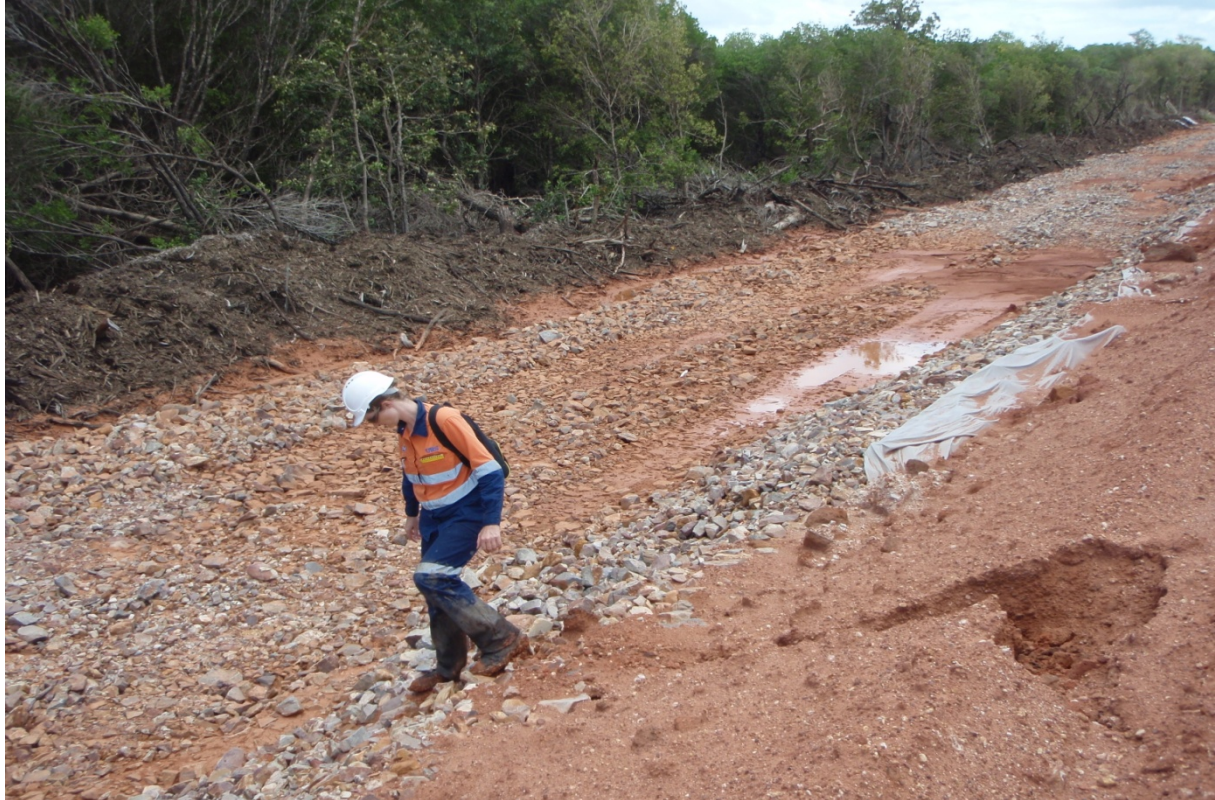
The use of mulch banks around the perimeter of the site have formed an effective barrier to sediment contained within surface water from moving into adjacent mangrove areas. In many areas around the site it was evident that fine silts had been deposited on the landward side of the mulch banks with little or no silt deposition occurring on the mangrove or seaward side of the banks (see **Plate 6-3**).

**Plate 6-3** Mulch bank (in middle to background) located on the perimeter of the site

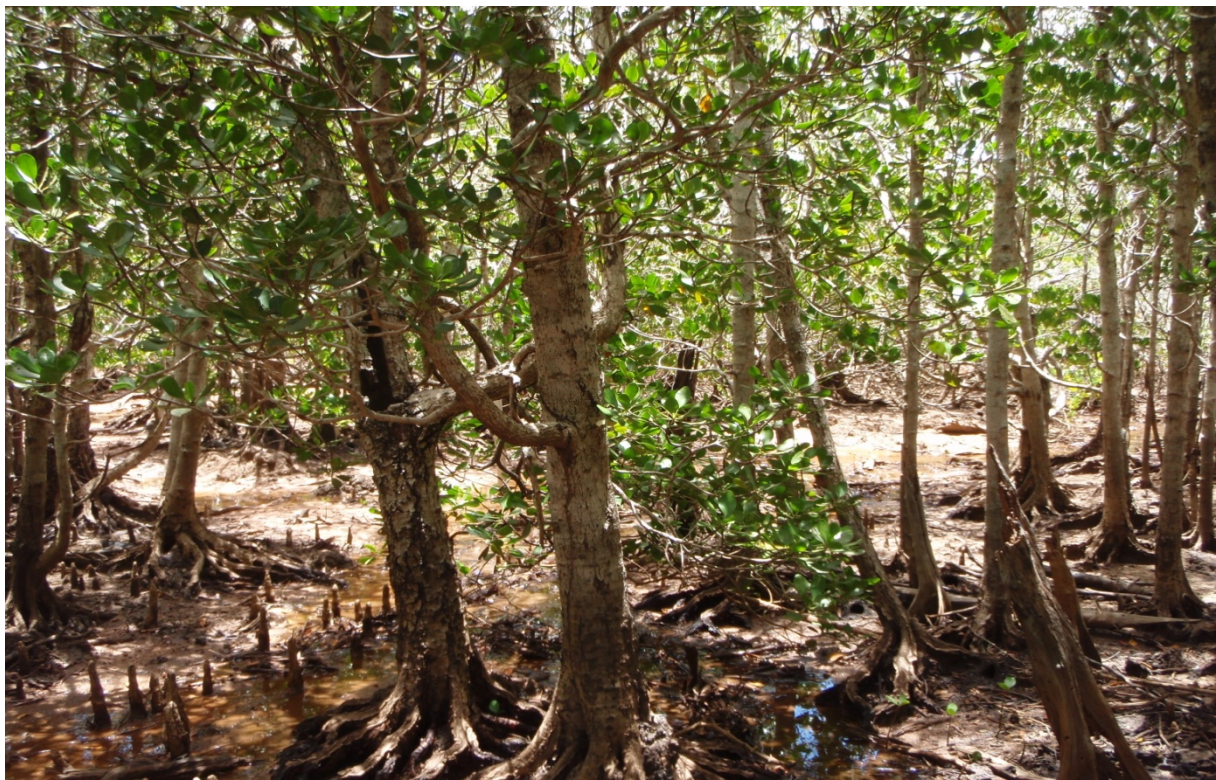
**Plate 6-4** Pooled water amongst mangroves at Site BPMC17 (March 2013). Water emanated from freshwater surface and seepage flows into hinterland fringe mangroves from adjacent terrestrial areas

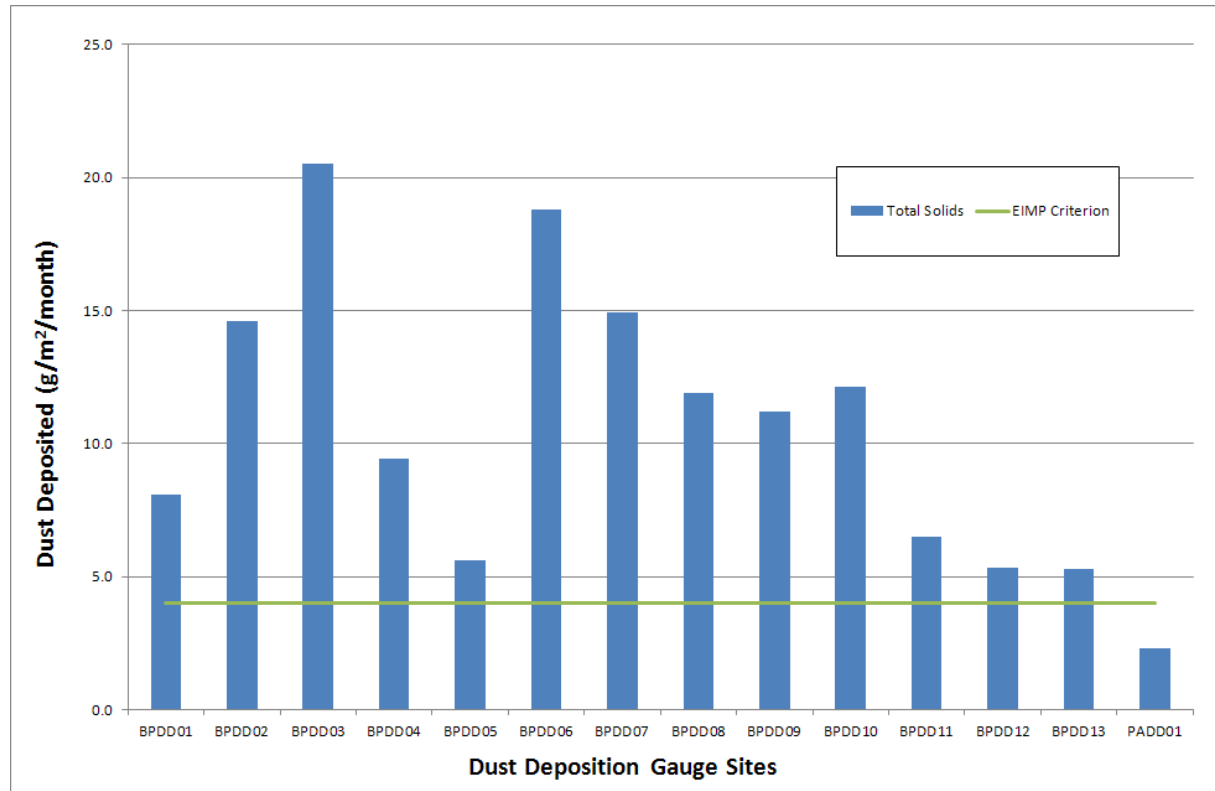
Chart 7-2 Average Dust Deposition (Total Solids) for June 2012 to March 2013 Monitoring Period

Average dust deposition rate was lowest at the Palmeston deposition gauge PADD01 and no exceedance of the EIMP dust deposition criterion was observed.

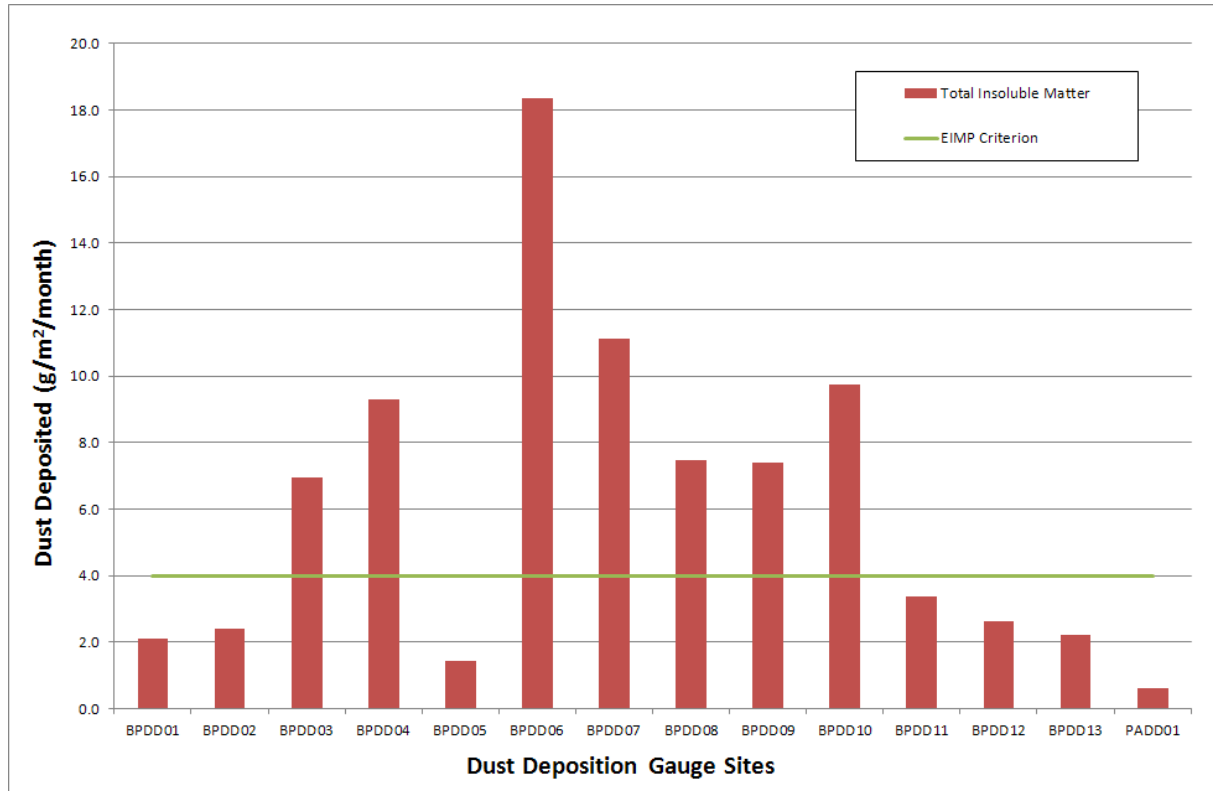
**Chart 7-3 Average Dust Deposition (Total Insoluble Matter) for November 2012 to March 2013 Monitoring Period**

The majority of the average dust deposition rates exceeded the EIMP criterion of 4 g/m<sup>2</sup>/month at on-site monitoring locations. The data presented here show a running average that is comparable to the EIMP criterion only after a 12-month period.

The sampling location at BPDD03 which recorded the highest average dust deposition rate is located close to and on the western side of the site access road. This station is likely to record vehicle-generated dust deposition, which is influenced by the prevailing south-easterly winds during the dry season months of monitoring (June to October 2012).

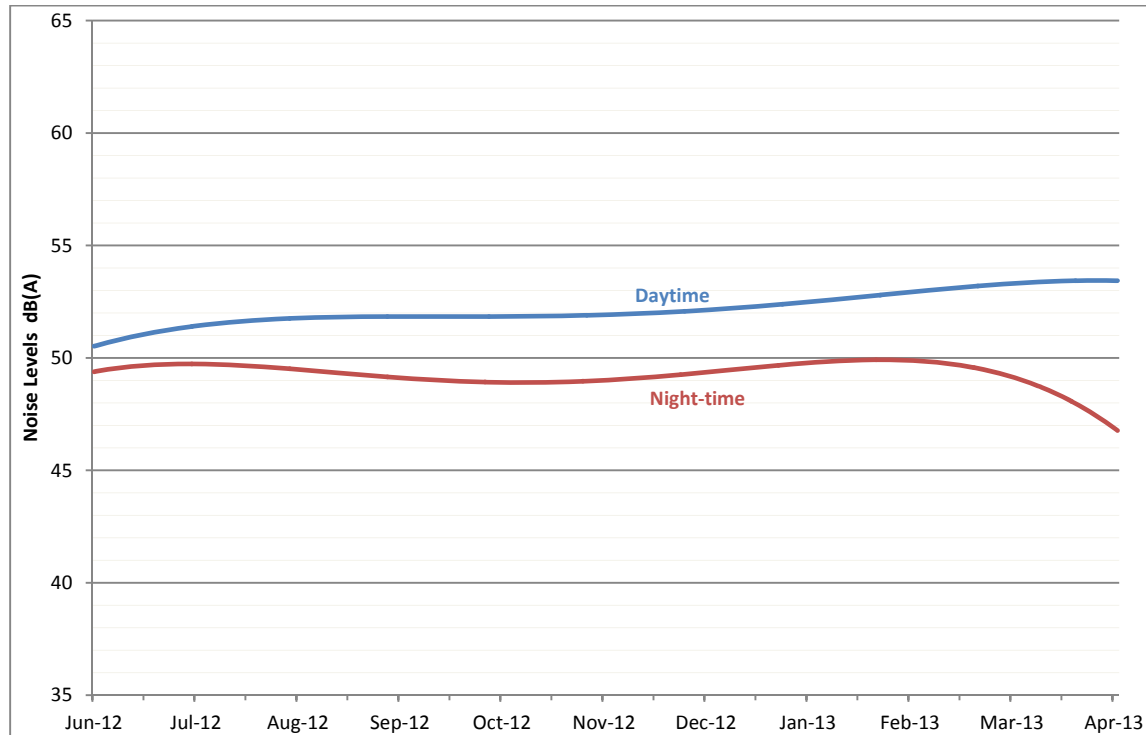
Chart 8-4 Palmerston Smoothed Noise Levels

**Chart 8-4** presents the trendline of noise levels at Palmerston. The trends show minimal variations of noise levels across the whole monitoring period. This variation is attributed to seasonal variability in ambient noise (i.e. wet season and dry season). From this chart, no correlation is observed with noise levels at the CWA site.
