EPA7 Annual Report 2016

Environmental Impact Monitoring Program

Ichthys On-Shore LNG Facilities

Bladin Point

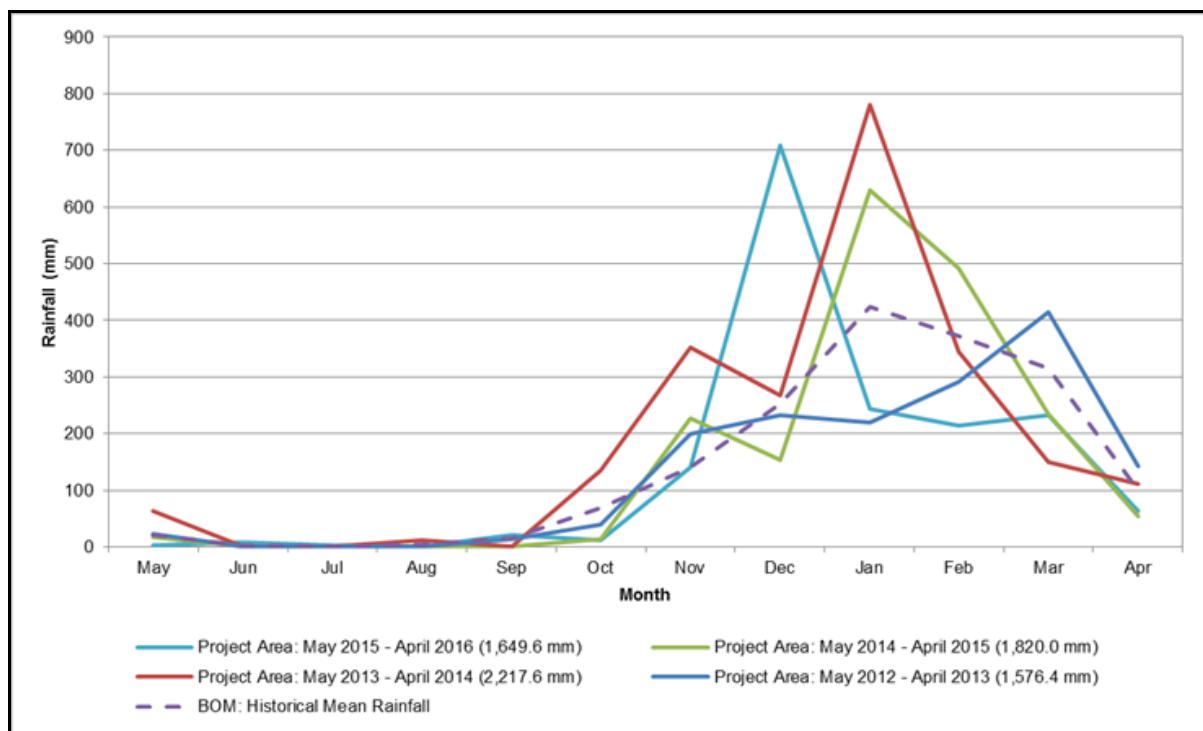
Figure 3-1 Summary of Climatic Data, May 2012 – April 2016

During the annual monitoring period, the Site received 1,649.6 mm of rainfall, with rain falling on 99 days, mainly in the wet season. April was the hottest month with a temperature range of 23.8°C minimum to 37.0°C maximum. A summary of the climatic data collected during the annual monitoring period is presented in **Figure 3-1**.

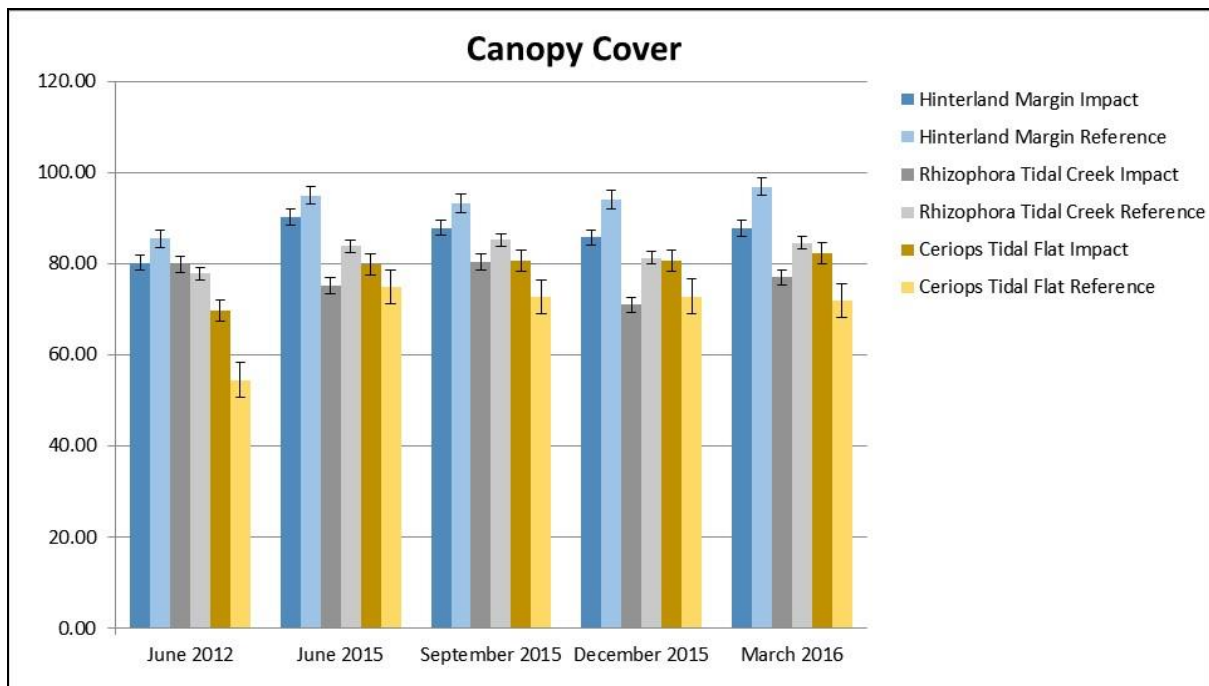
Figure 4-13 Canopy Cover (mean values) Summarised for each Mangrove Assemblage

No discernible decline in mangrove community health was detected at the 20 impact sites surveyed during the annual monitoring period and this indicated that the mangrove communities located close to the Site have remained in a healthy condition.
