EPA7 Annual Report 2015 Environmental Impact Monitoring Program

Ichthys On-Shore Liquefied Natural Gas Facilities

Bladin Point

Date: 28th July 2015

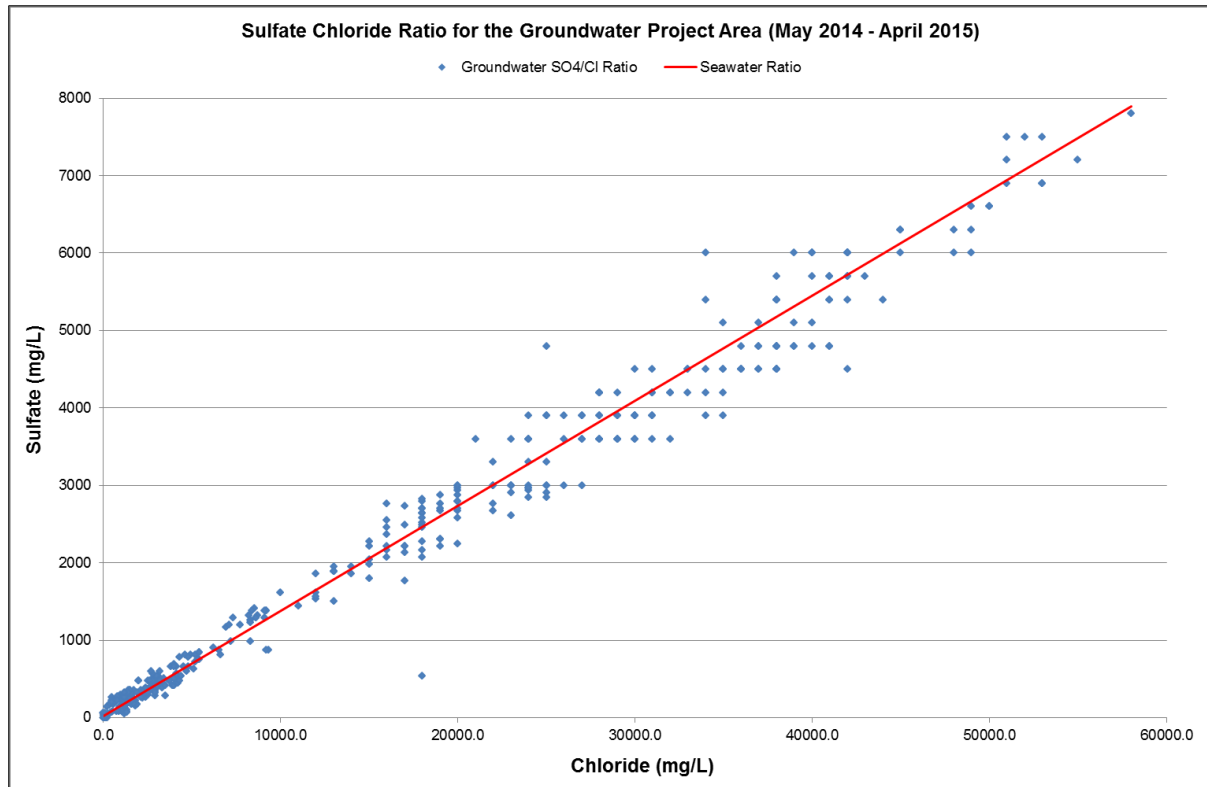
Figure 4-10 Sulfate/Chloride Ratio

The potential influence from ASS on groundwater quality was assessed using sulfate/chloride ratios. A typical sulfate-chloride ratio for seawater is 0.14 (19,400 mg/L chloride and 2,700 mg/L of sulfate). As the ratios of the dominant ions in saline water remains approximately the same when diluted with rainwater, estuaries, coastal saline creeks and associated groundwater can be expected to have similar ratios to the dominant ions in seawater (Mulvey, 1993). Where the analysis indicates that there is an elevated level of sulfate ions relative to the chloride ions, these results provide a good indication of the presence of acid sulfate soils in the landscape. A Cl⁻:SO₄²⁻ ratio of less than four and certainly a ratio less than two, is a strong indication of an extra source of sulfate from previous sulfide oxidation (Mulvey, 1993).

In other words, a greater ratio would indicate a potential influence from a sulfate-containing source e.g. ASS oxidation. A lower ratio would indicate a sulfate salt precipitation or dilution with water, with minor sulfate content, e.g. rainwater. **Figure 4-10** shows that the sulfate-chloride ratio for onsite groundwater was generally consistent with the typical seawater ratio, indicating a negligible influence from sulfate generation sources and some influence from dilution. Accordingly, the overall influence on groundwater quality from potential oxidation of ASS was likely to be insignificant.
