EPA7 Annual Report 2017

Environmental Impact Monitoring Program

Ichthys On-Shore LNG Facilities

Bladin Point

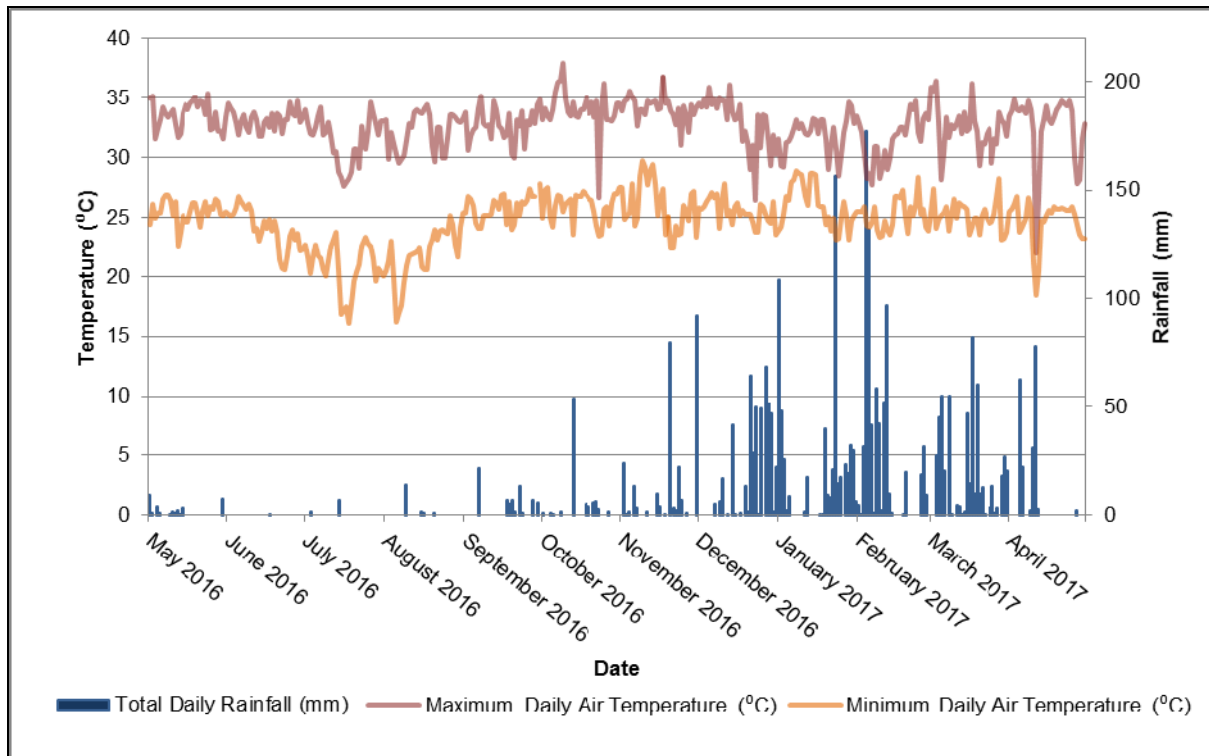
Figure 3-1 Summary of Climatic Data, May 2016 – April 2017

During the annual monitoring period, the Site received 3,024.0 mm of rainfall, with rain falling on 145 days, mainly in the wet season. October was the hottest month with a temperature range of 23.4°C minimum to 38.0°C maximum. A summary of the climatic data collected during the annual monitoring period is presented in **Figure 3-1**.

Rainfall recorded during the annual monitoring period was substantially higher than the historical average for Darwin (1,728.2 mm) and the average rainfall for all previous annual monitoring periods (1,815.9 mm). The 2016 dry season had unusually high rainfall with 70.4 mm of rainfall in September 2016, and a dry season total of 119.6 mm compared to an onsite historical average of 41.4 mm.

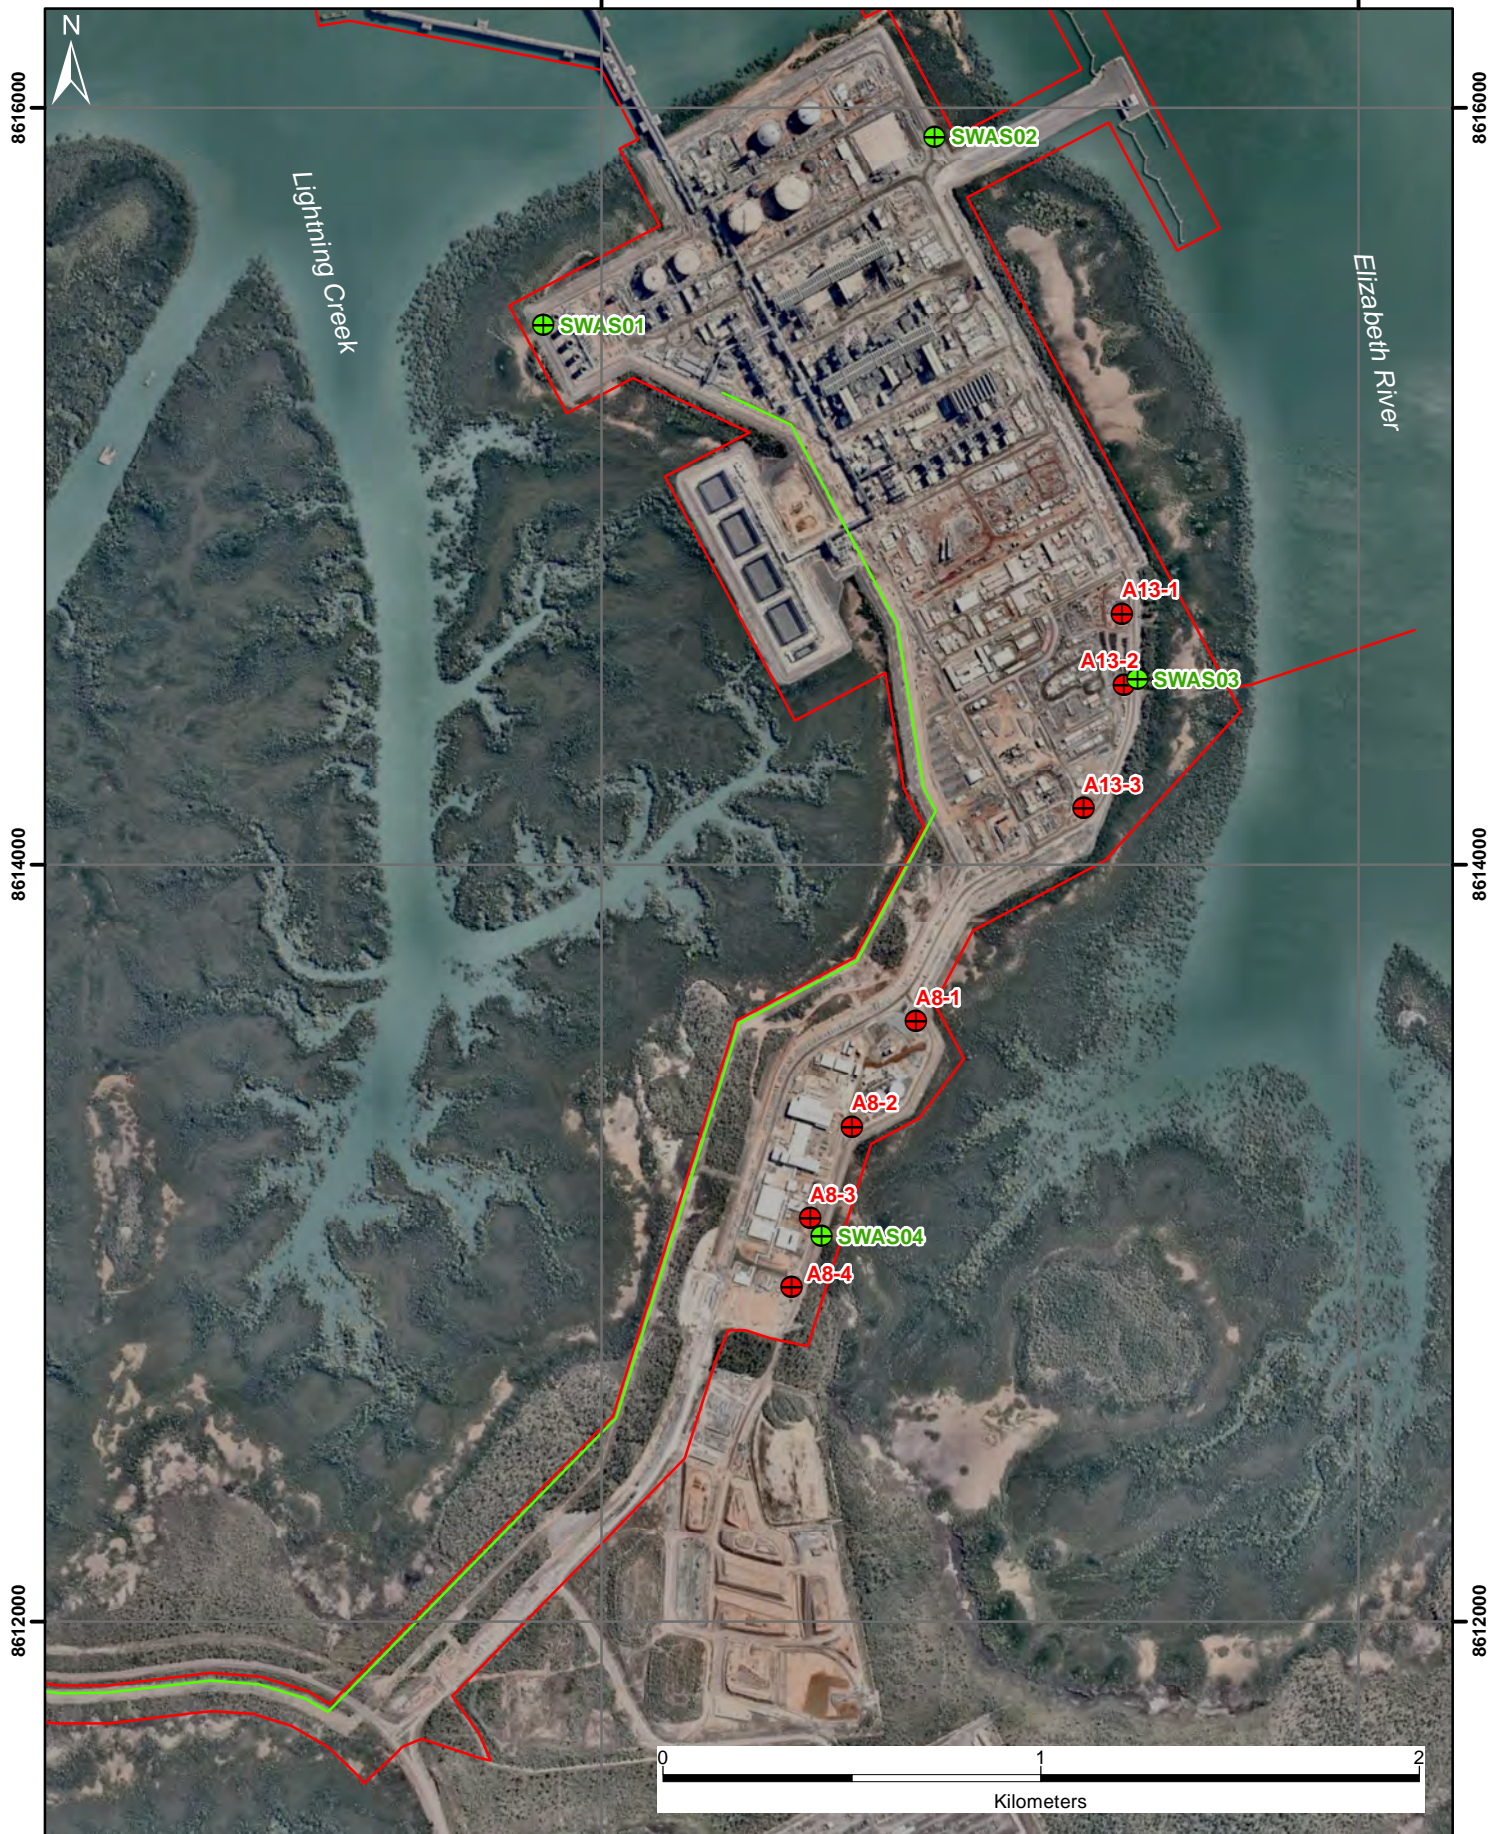
Site Boundary

Gas Export Pipeline

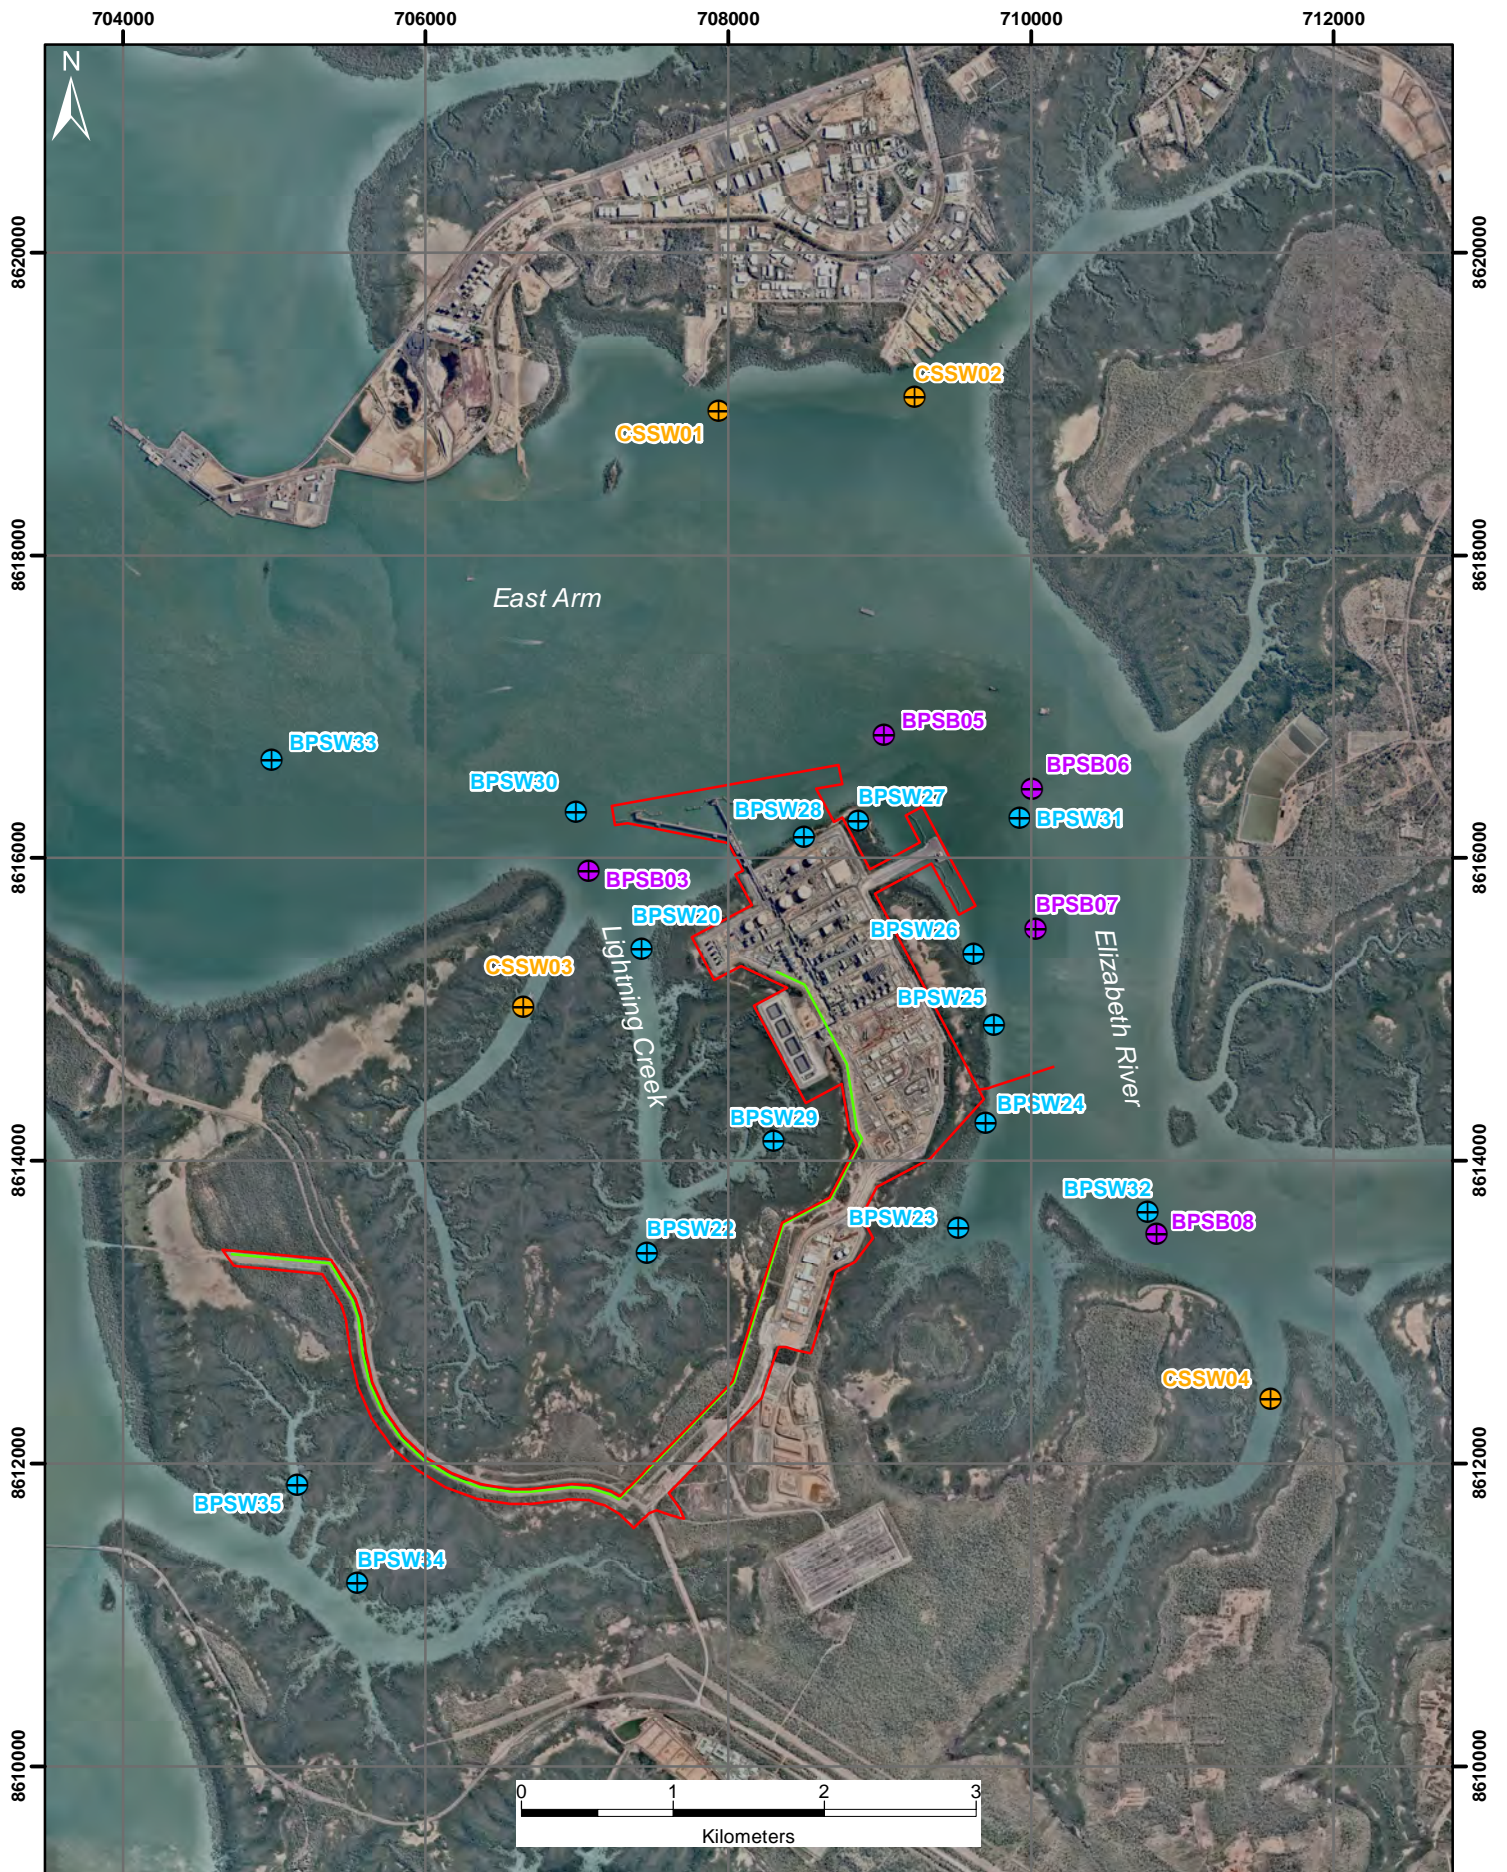
Surface Water Monitoring Locations

— Site Boundary
— Gas Export Pipeline

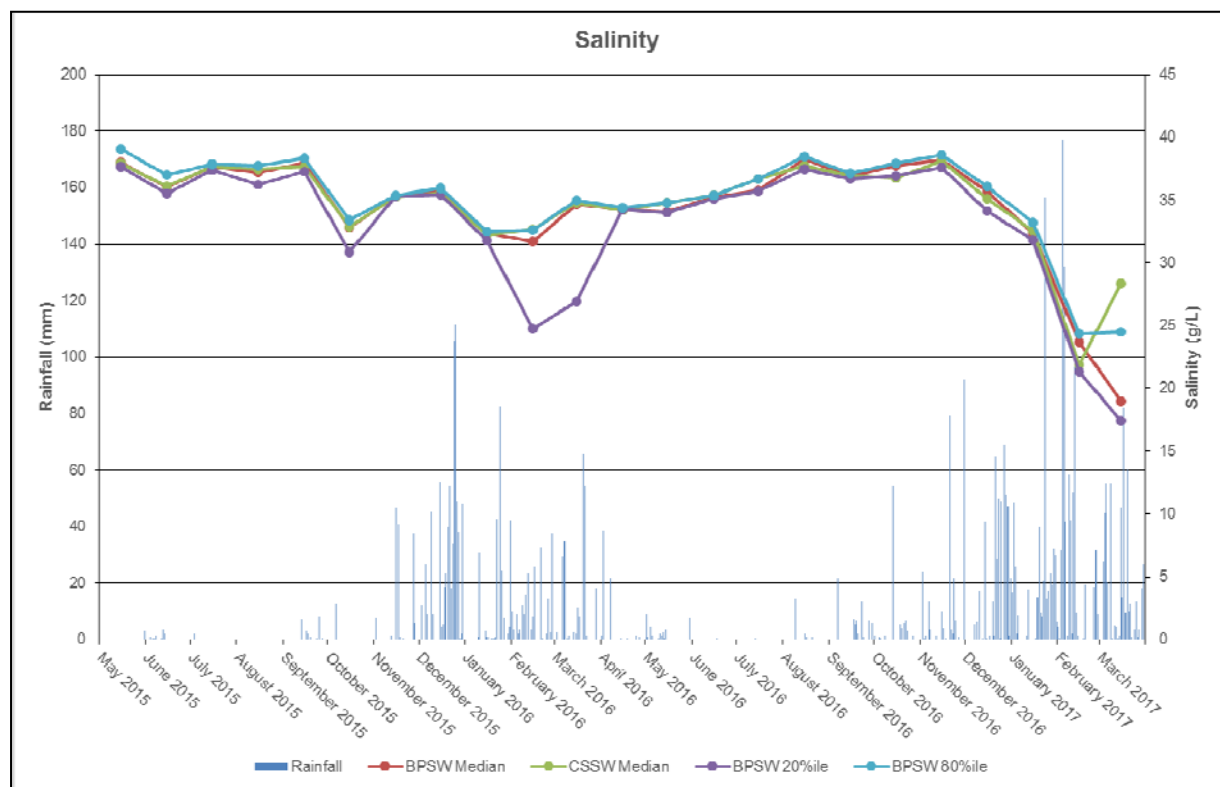
Figure 4-4 Marine Surface Water Salinity vs Daily Rainfall, May 2015 to April 2017

Figure 4-4 presents the salinity data trends from May 2015 to April 2017.

- During the dry season, salinity remained relatively stable with values ranging between 33.89 and 39.00 g/L with a median of 35.83 g/L;
- Median salinity was highest in November 2016 with a value of 38.18 g/L;
- From December 2016 onwards, salinity decreased (median of 35.73 g/L) as a result of dilution associated with a number of heavy rainfall events;
- The wet season salinity in this annual monitoring period (median of 32.37 g/L) was marginally lower than the 2015/16 wet season (median of 34.00 g/L) but significantly higher than the 2014/15 wet season (median of 24.30 g/L). This result is unusual given the fact that the 2016/17 wet season was the wettest since monitoring began on the Project; and
- Salinity during the dry season (median 35.83 g/L) was higher than the salinity during the 2014 and 2015 dry seasons (33.00 and 33.10 g/L, respectively).

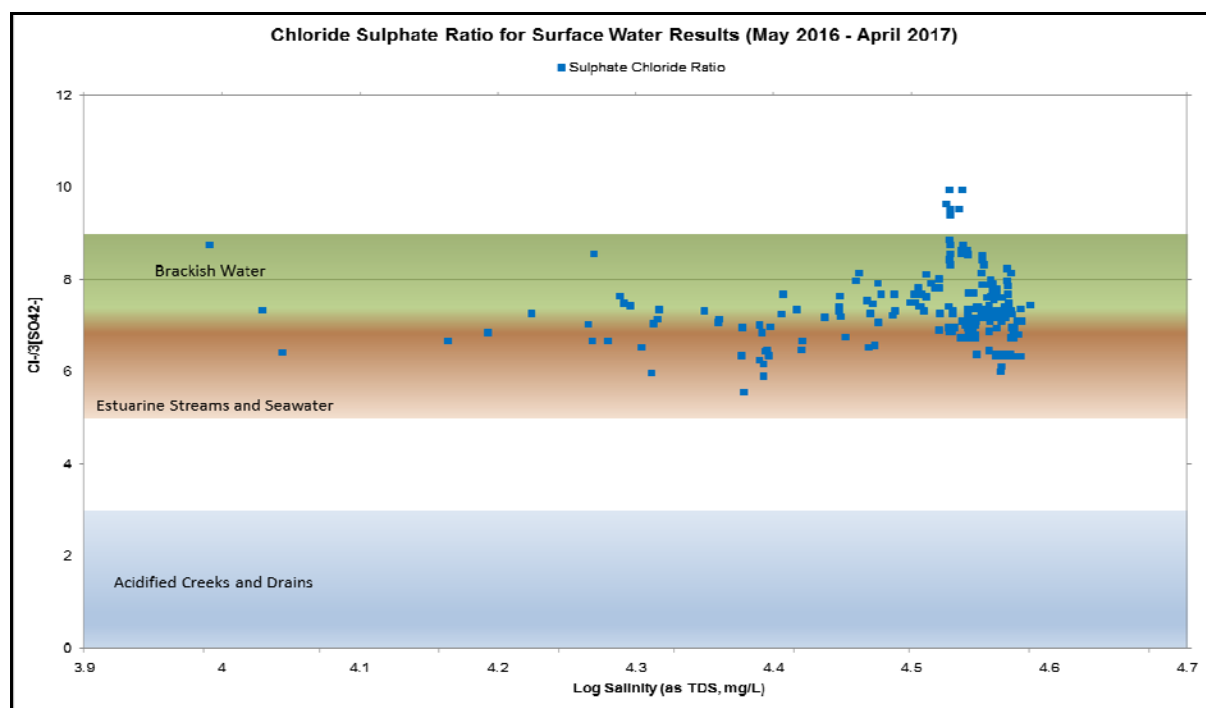
Figure 4-5 Surface Water Chloride/Sulphate Ratio

Chloride/sulphate ratios can be used to determine whether there has been discharge from ASS-impacted streams into marine receptors. Chloride/sulphate ratios are often <3 in ASS-impacted streams, whereas ratios between ~5 and 7 are expected in estuarine streams (Sammur *et al.*, 1996). A chloride/sulphate ratio of less than four and certainly a ratio less than two, is a strong indication of an extra source of sulphate from previous sulphide oxidation (Mulvey, 1993). Salinity results from the surface water monitoring program, while slightly higher than previous annual monitoring periods, remained consistent with seawater with a number of exceptions that were indicative slightly fresher water (**Figure 4-5**) and it can be concluded that there have not been discharges from ASS-impacted streams into the marine receiving environment. In addition, the data that were collected during this annual monitoring period were similar to all previous annual monitoring periods.

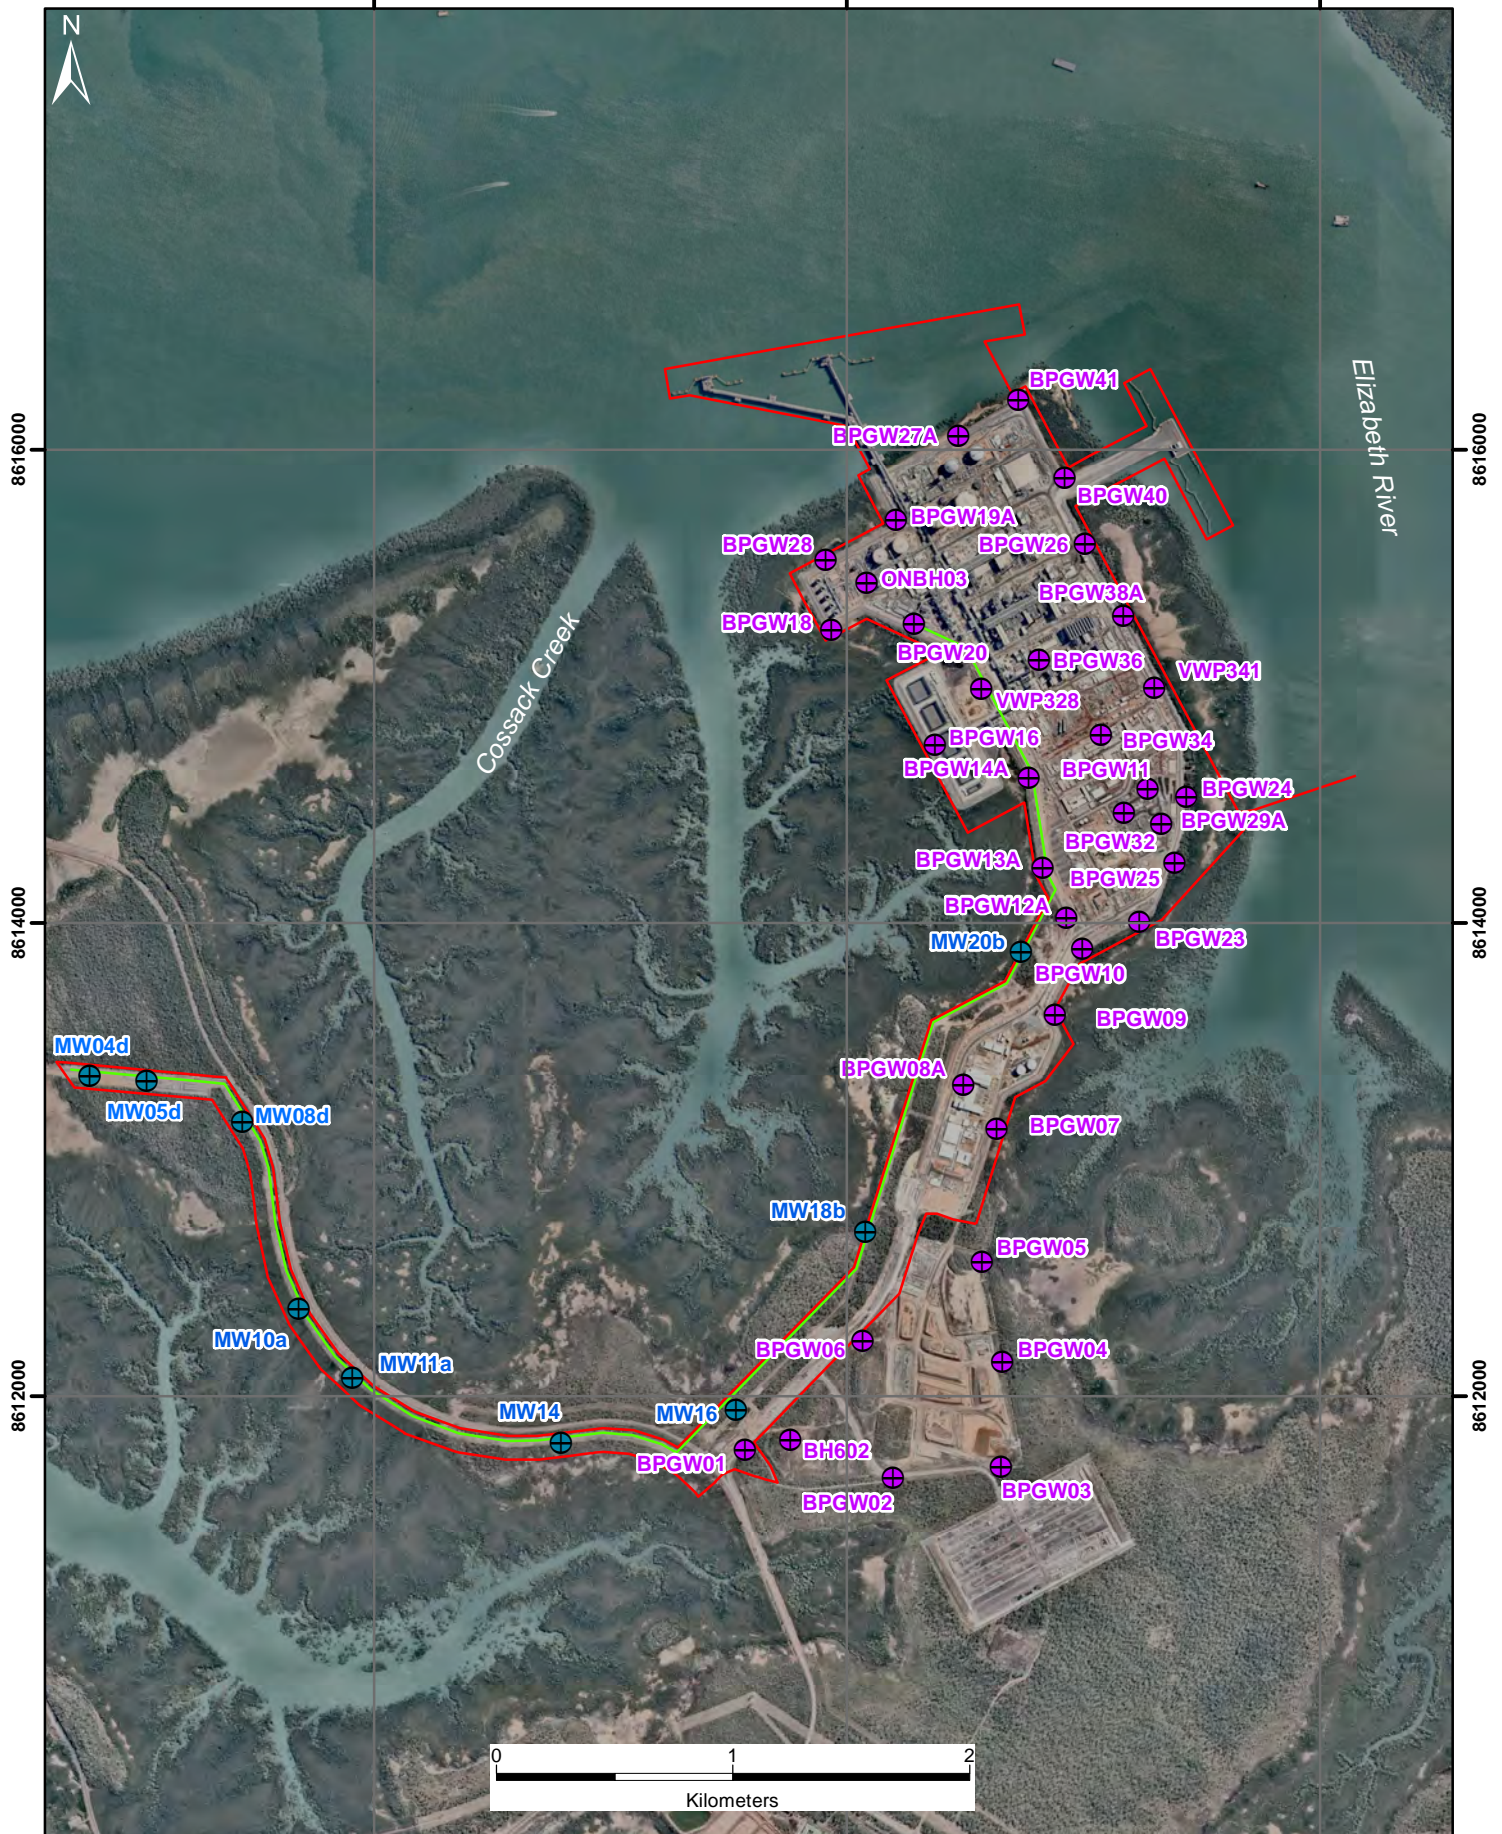
- Gas Export Pipeline **Monitoring Locations**
— Site Boundary ● Groundwater Sampling Locations
● EIMP (Rev 6) GEP Groundwater Sampling Locations

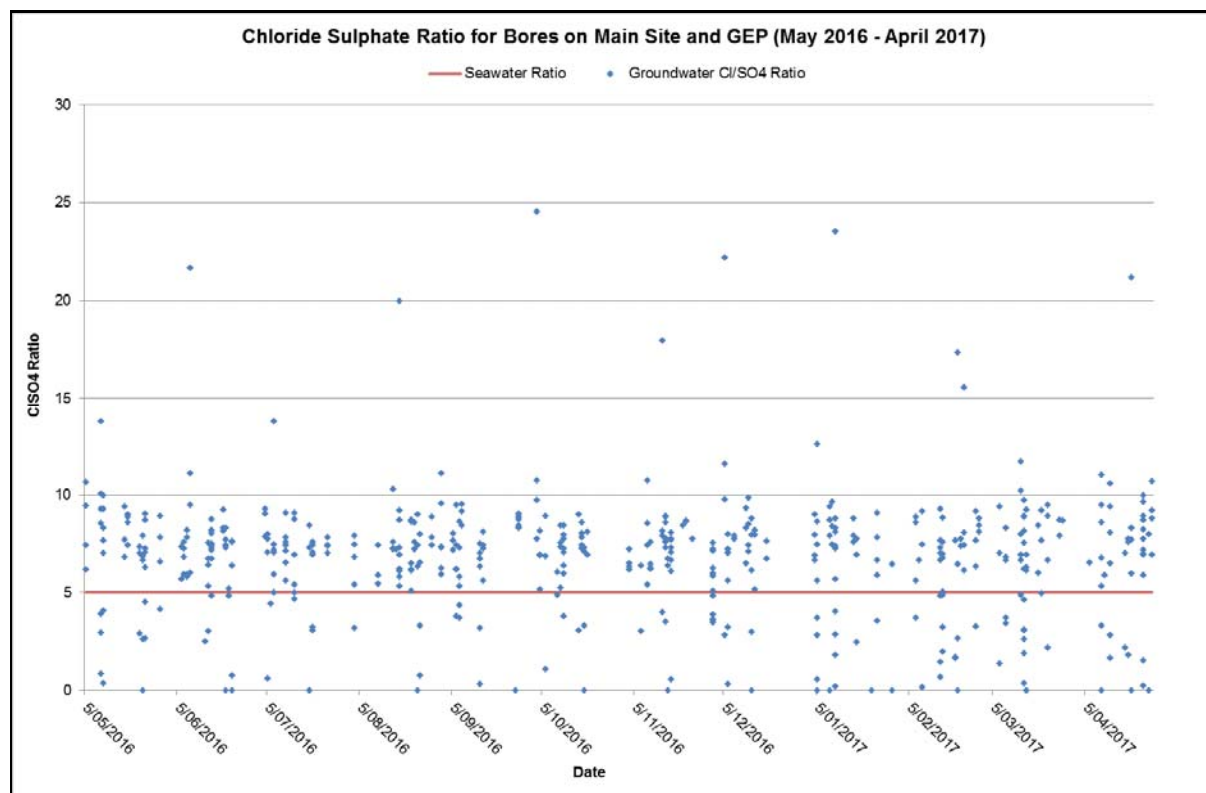
Figure 4-9 Chloride/Sulphate Ratio for Bores on Site and GEP

A low chloride/sulphate ratio would indicate a potential influence from a sulphate-containing source e.g. ASS oxidation. A higher ratio would typically indicate a sulphate salt precipitation or dilution with water, with minor sulphate content, e.g. rainwater. Groundwater was consistent with the typical seawater ratio (**Figure 4-9**), indicating a negligible influence from sulphate generation sources and some influence from dilution.

A lower chloride/sulphate ratio was noted in specific bores located to the south of the isthmus (e.g. BPGW01, BPGW03, BPGW04 and BPGW05) during the wet season. This was assessed to be related to significant, seasonal freshwater recharge in these bores and the natural presence of sulphate salts in the soils, and was not a result of any ASS impacts. This was further evidenced by the fact that these bores are not located in potential PASS/ASS areas and Mann-Kendall statistical analysis did not indicate any decreasing trends in chloride/sulphate ratios in these bores.

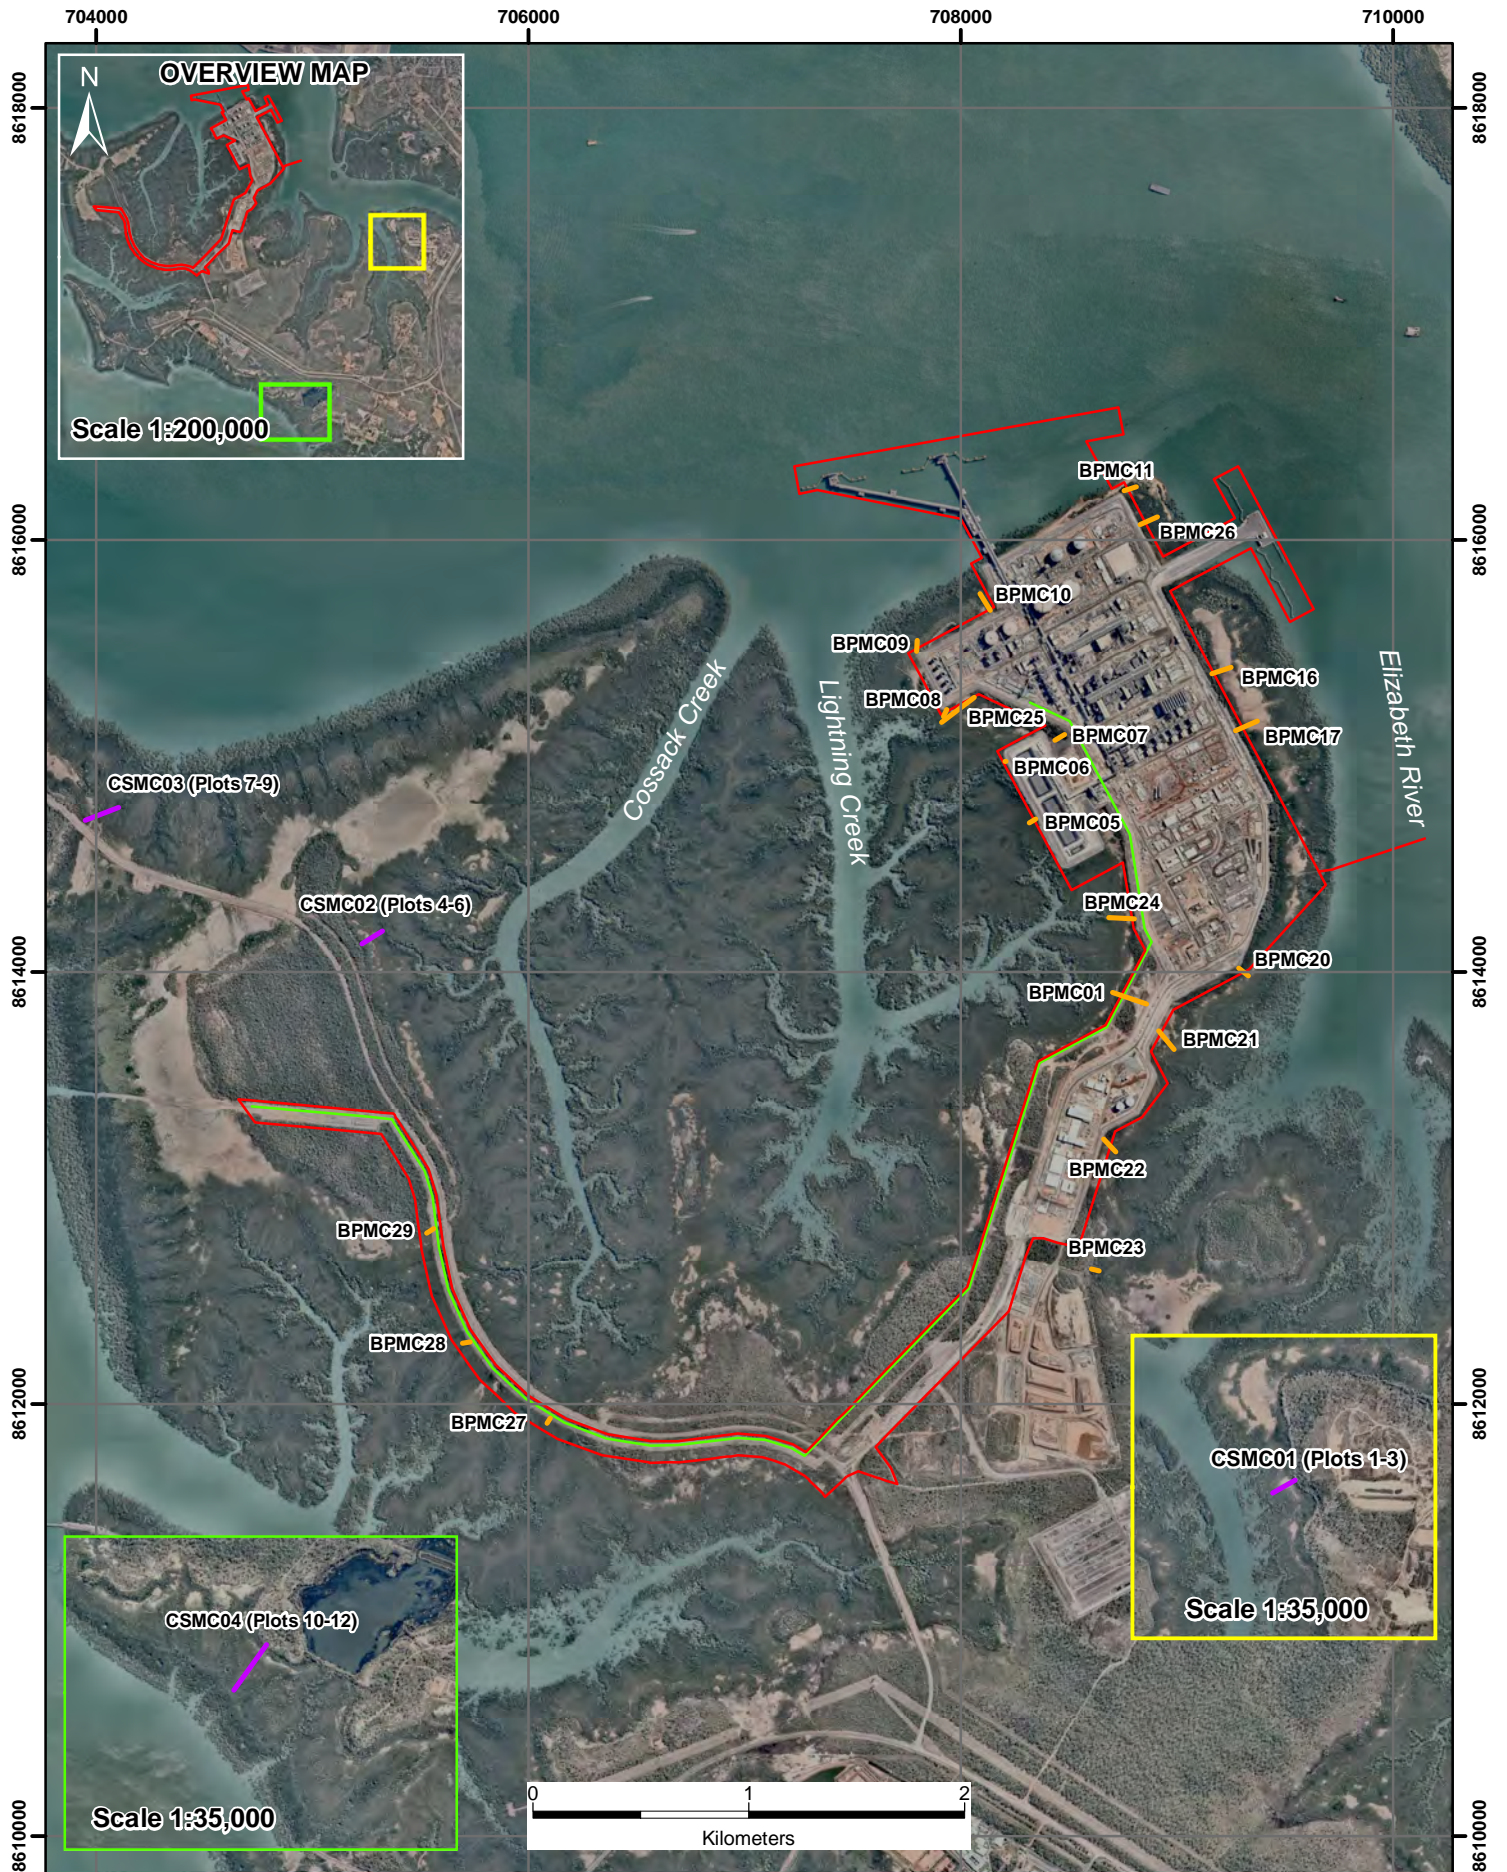
Mangrove Monitoring Locations

- Site Boundary
- Mangrove Transects
- Gas Export Pipeline
- Mangrove Transects (Reference Sites)

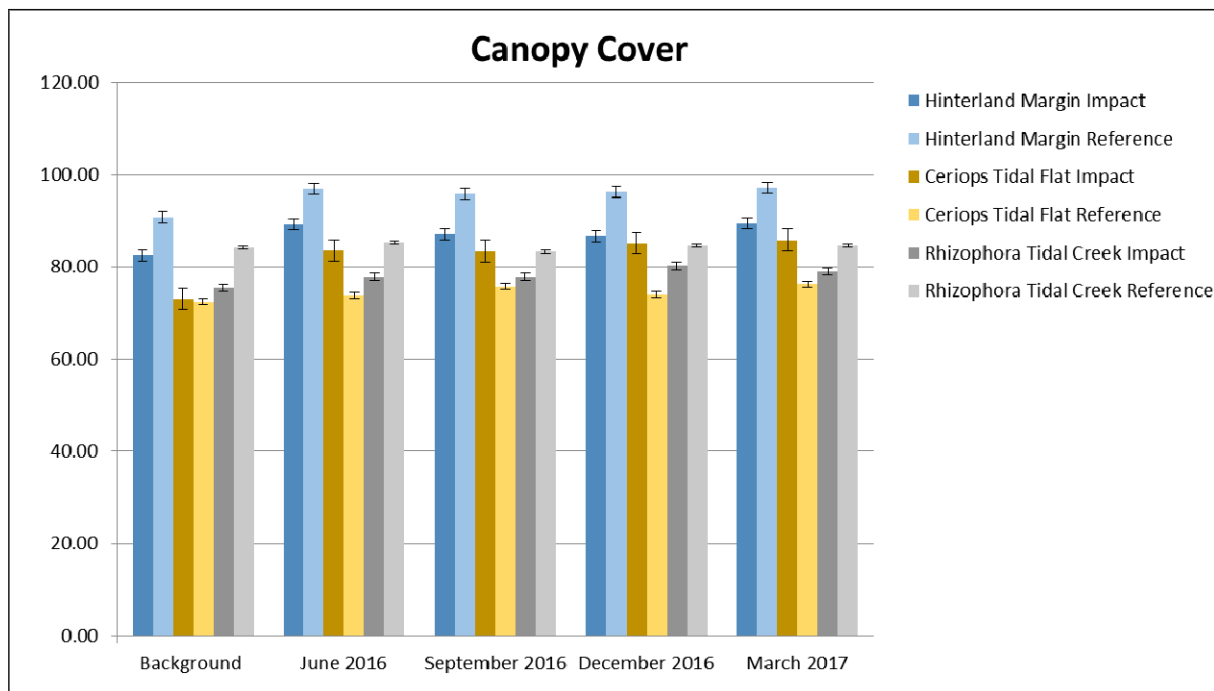
Figure 4-11 Mean Canopy Cover Summarised for each Mangrove Assemblage

Canopy cover data has been summarised in **Figure 4-11** by comparing mean canopy cover for the three mangrove assemblages monitored, namely:

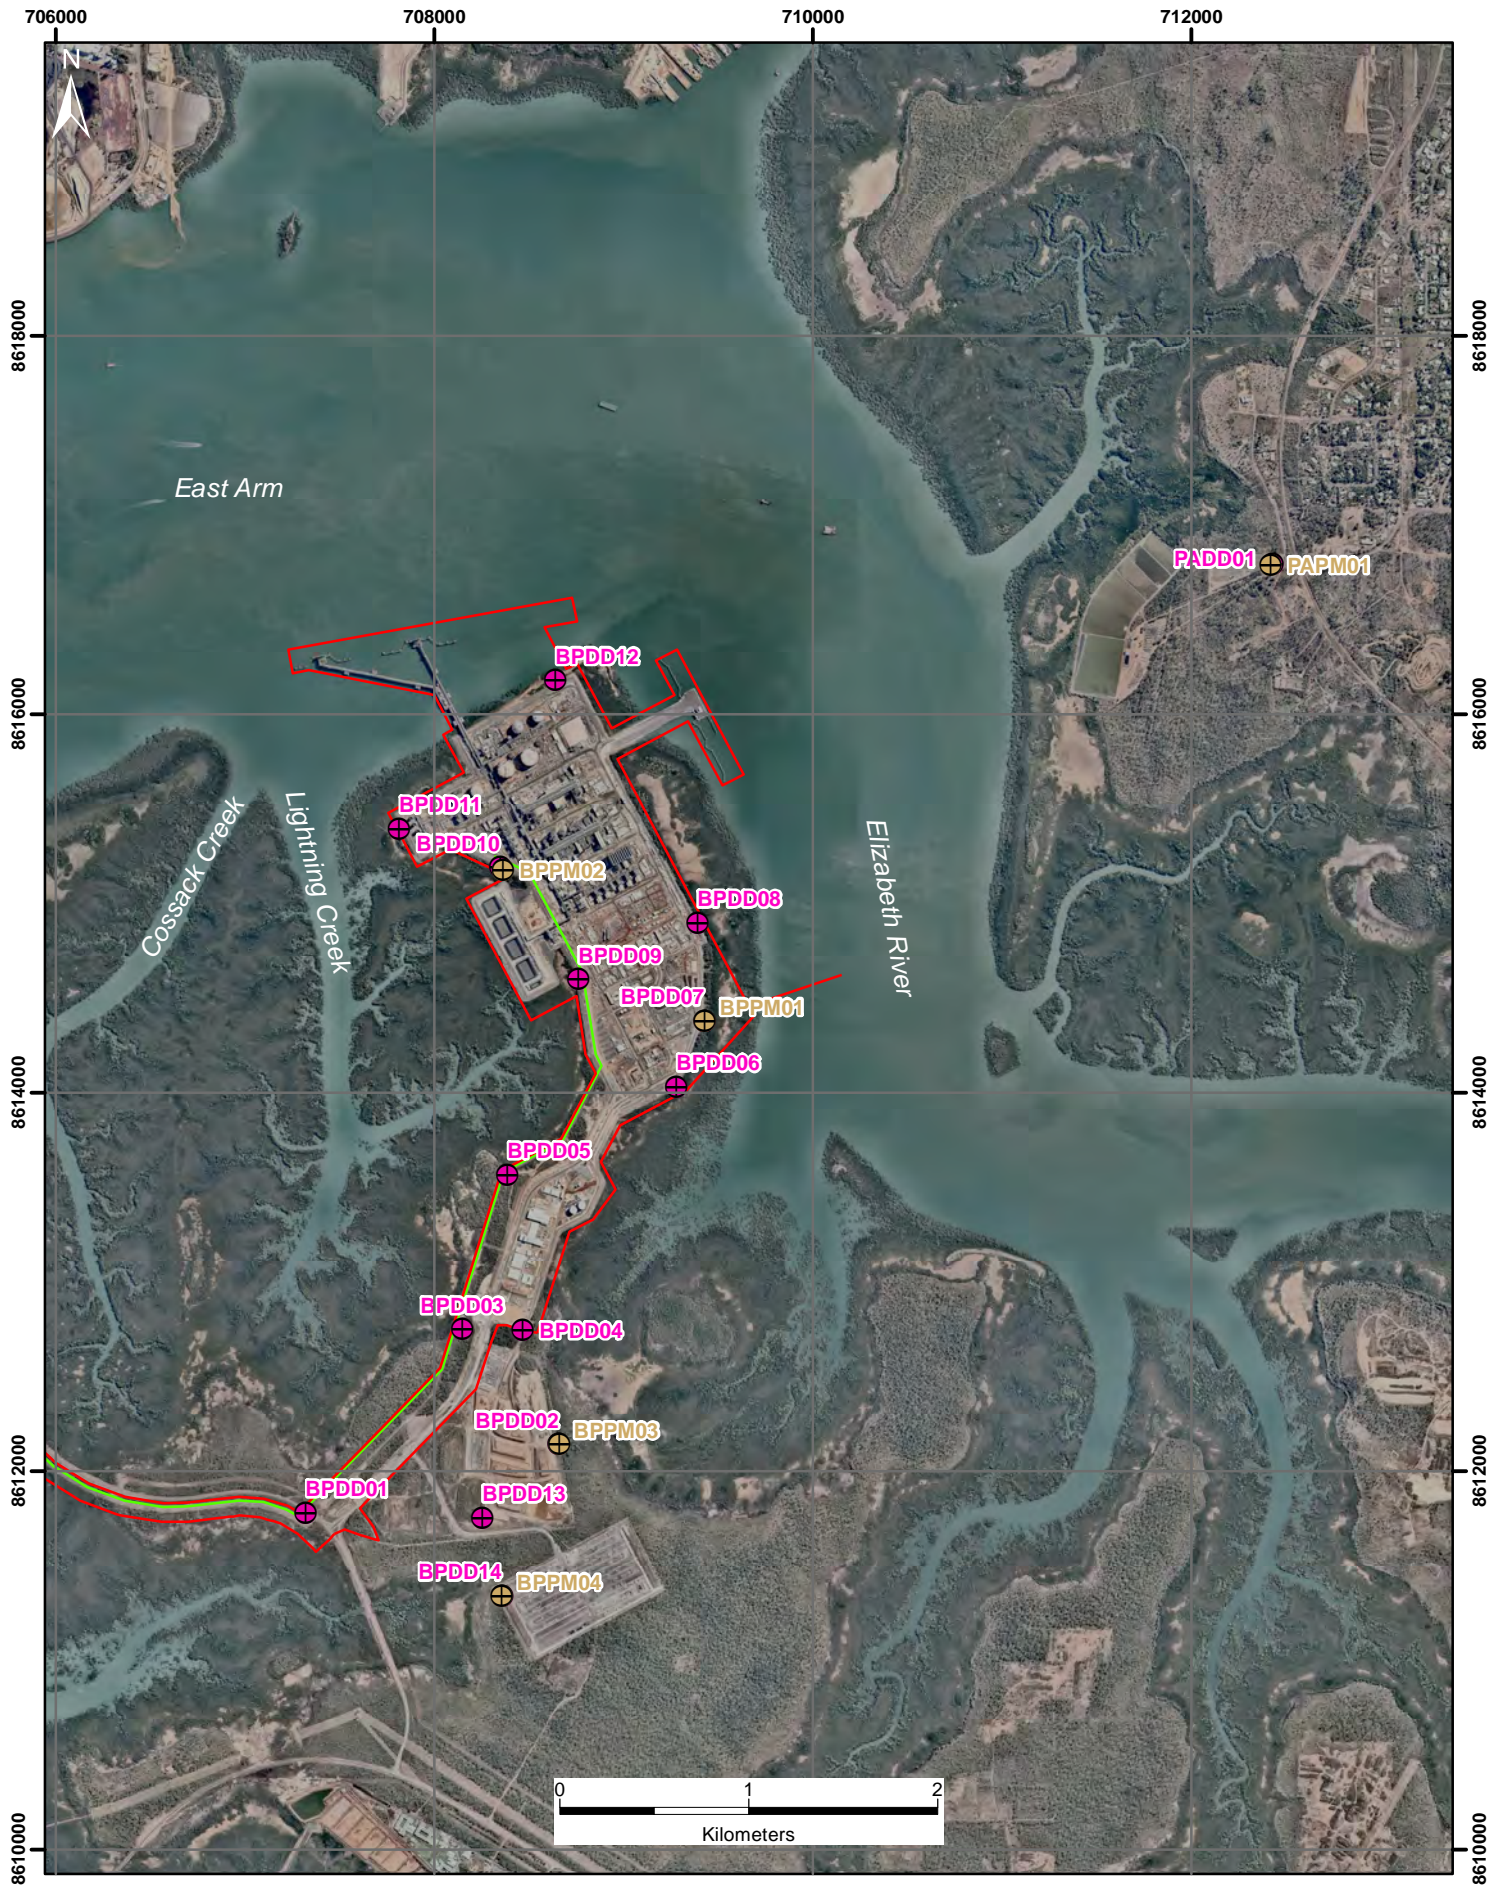
Dust Monitoring Locations

- Site Boundary
- Gas Export Pipeline
- Dust Monitoring Location (Dust Deposition Sample)
- Dust Monitoring Location (Particulate Matter Sample)

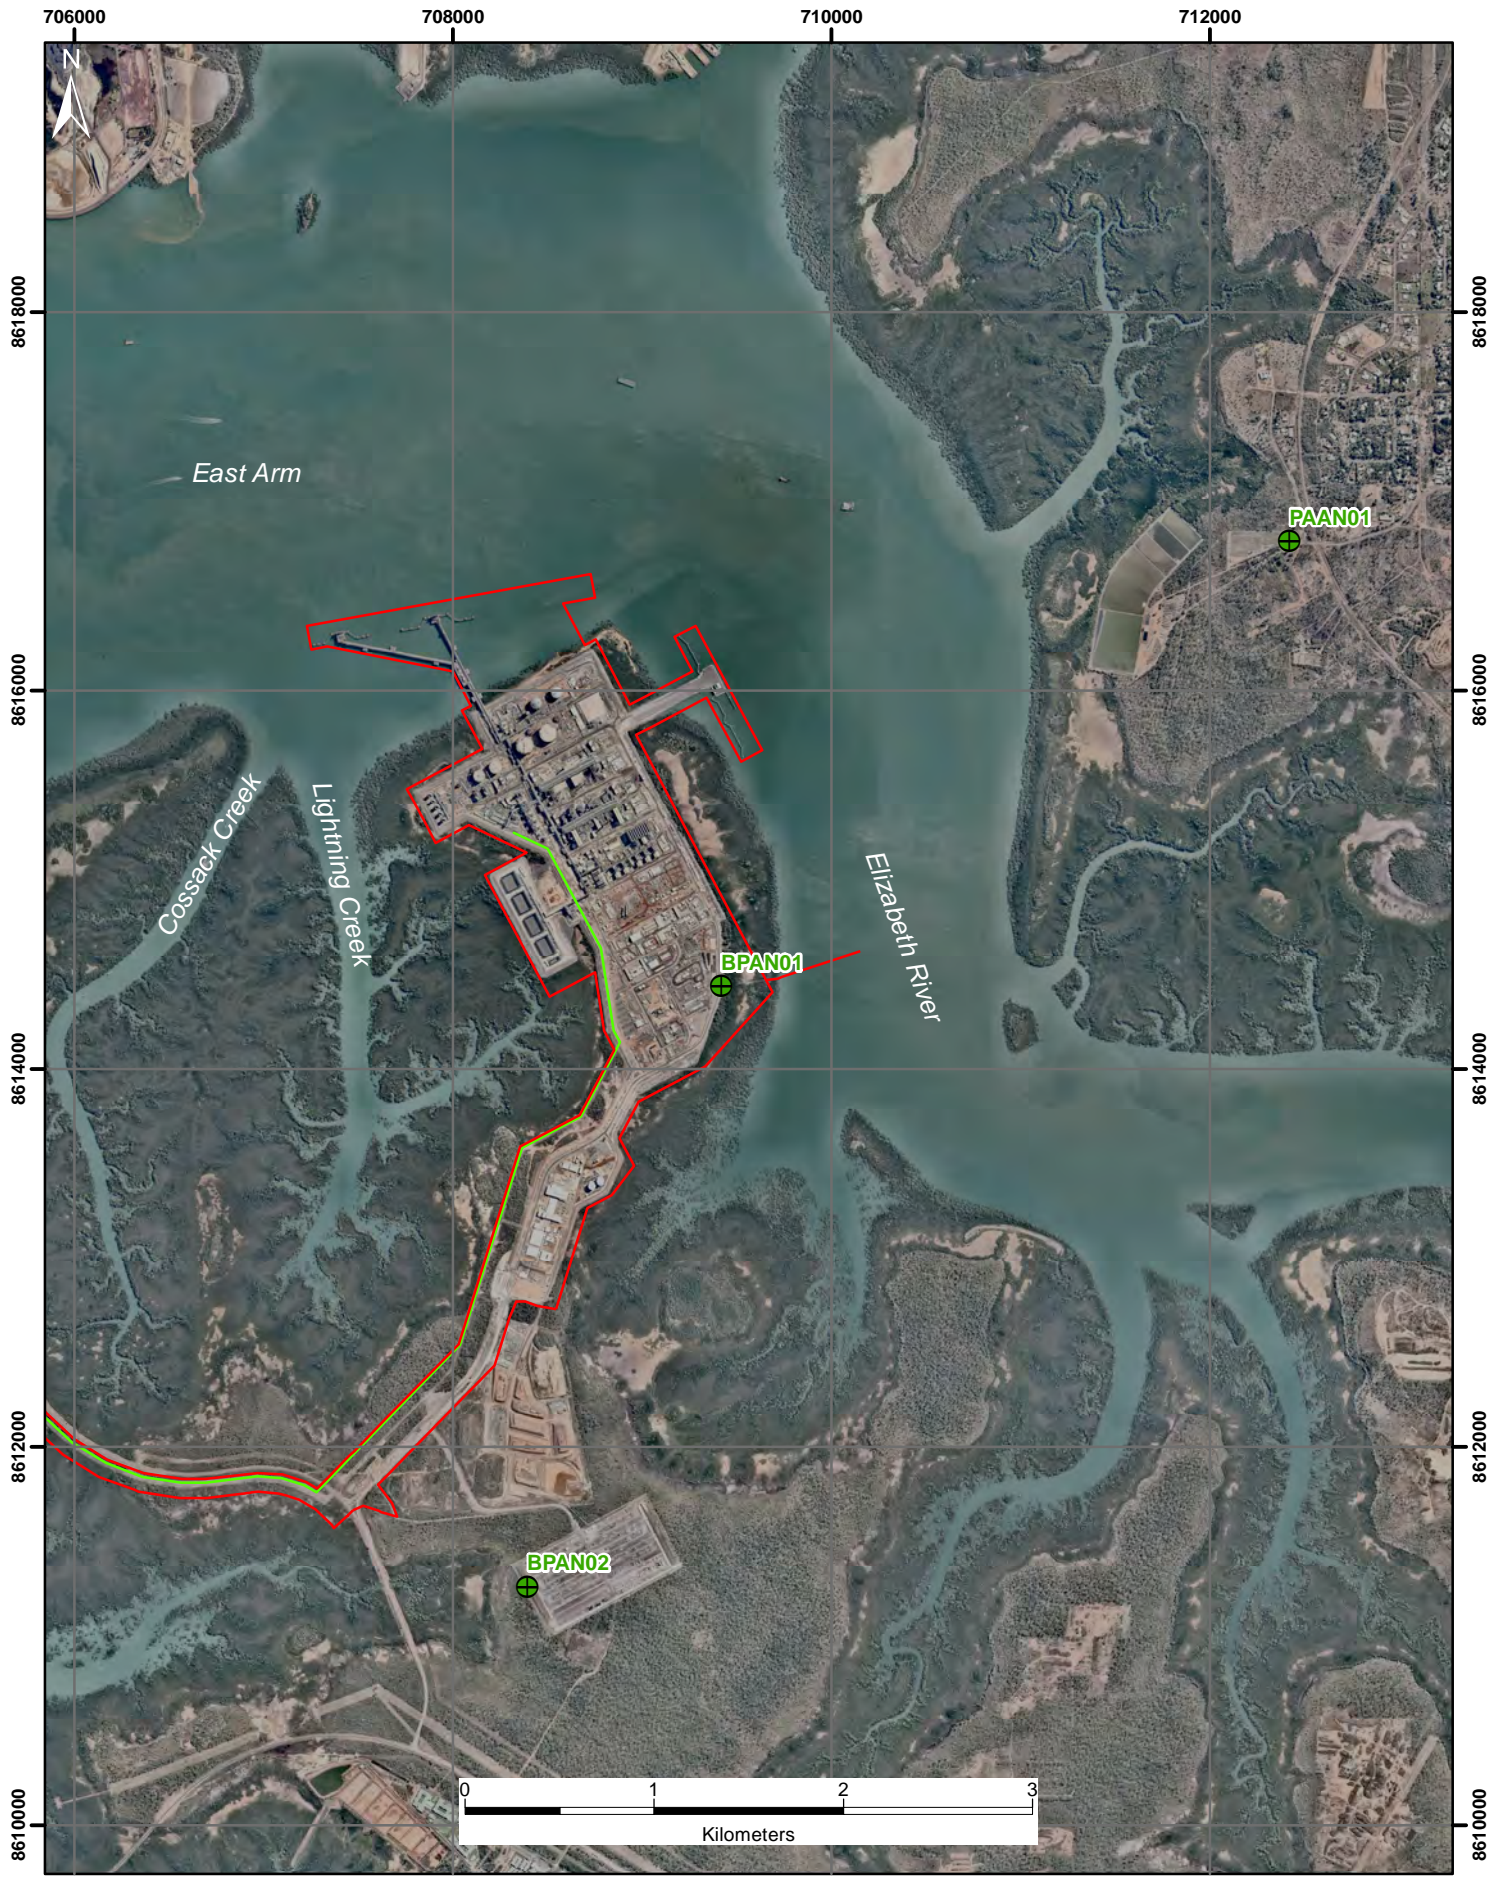
- Site Boundary
- Gas Export Pipeline
- Noise Monitoring Locations

Noise Monitoring Locations		
Figure 4-13	INPEX Bladin Point	
Date: 14/07/2017		
Revision: A		
<div> <div>Author: malcolm.nunn</div> <div>Map Scale: 1:40,000</div> <div>Coordinate System: GDA 1994 MGA Zone 52</div> </div>

Monitoring occurred at three locations during the annual monitoring period (BPAN01, BPAN02 and PAAN01) (**Figure 4-13**).
