Subcontractor's name	Greencap Pty Ltd
Subcontract No.	0 - 6037- P- 3365-SC119
Subcontract Package Name:	ENVIRONMENTAL IMPACT MONITORING PROGRAM
DOCUMENT TITLE:	EPA7 ANNUAL REPORT 2018 - ENVIRONMENTAL IMPACT MONITORING PROGRAM
Subcontractor's Doc. No.:	AEC307

**EPA7 Annual Report 2018
Environmental Impact Monitoring Program**

Ichthys On-Shore LNG Facilities

Bladin Point

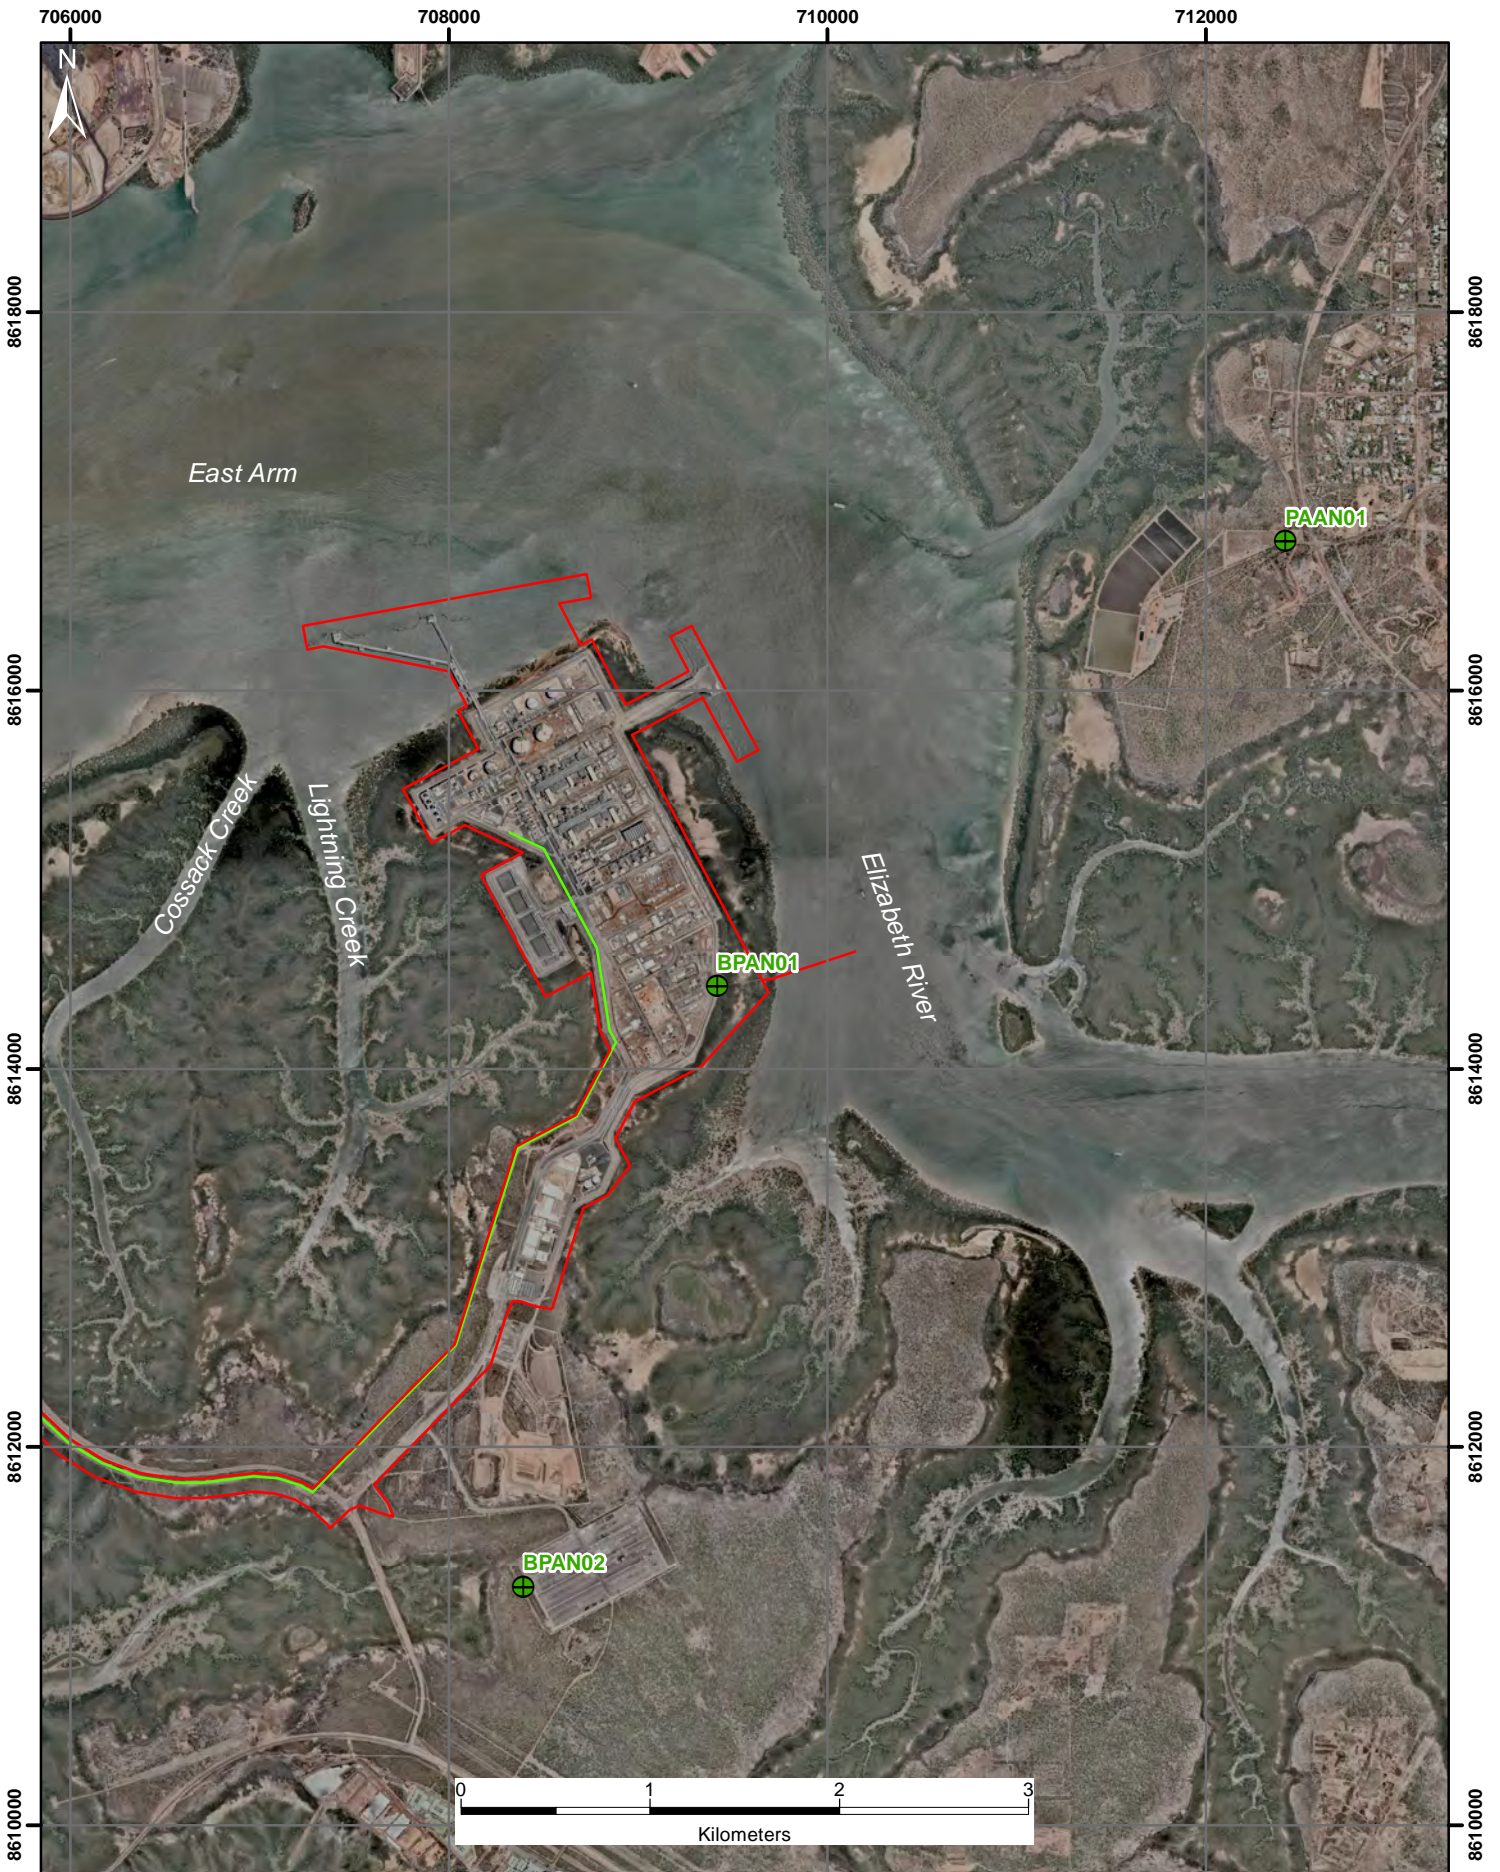
Noise Monitoring Locations		
Figure 4-13	INPEX Bladin Point	GREENCAP
Date: 8/05/2018	<small>Author: malcolm.nunn Map Scale: 1:40,000</small>	
<small>Revision: A</small>	<small>Coordinate System: GDA 1994 MGA Zone 52</small>

- Site Boundary
- Gas Export Pipeline
- ⊕ Noise Monitoring Locations

Monitoring occurred at three locations during the annual monitoring period (BPAN01, BPAN02 and PAAN01) (**Figure 4-13**).
