| Subcontract Package Name: | ENVIRONMENTAL IMPACT MONITORING PROGRAM |
| DOCUMENT TITLE: | EPA7 ANNUAL REPORT 2019 - ENVIRONMENTAL IMPACT MONITORING PROGRAM |

| <p>ICHTHYS ONSHORE LNG FACILITIES</p> <p>Darwin, Australia</p> | | |

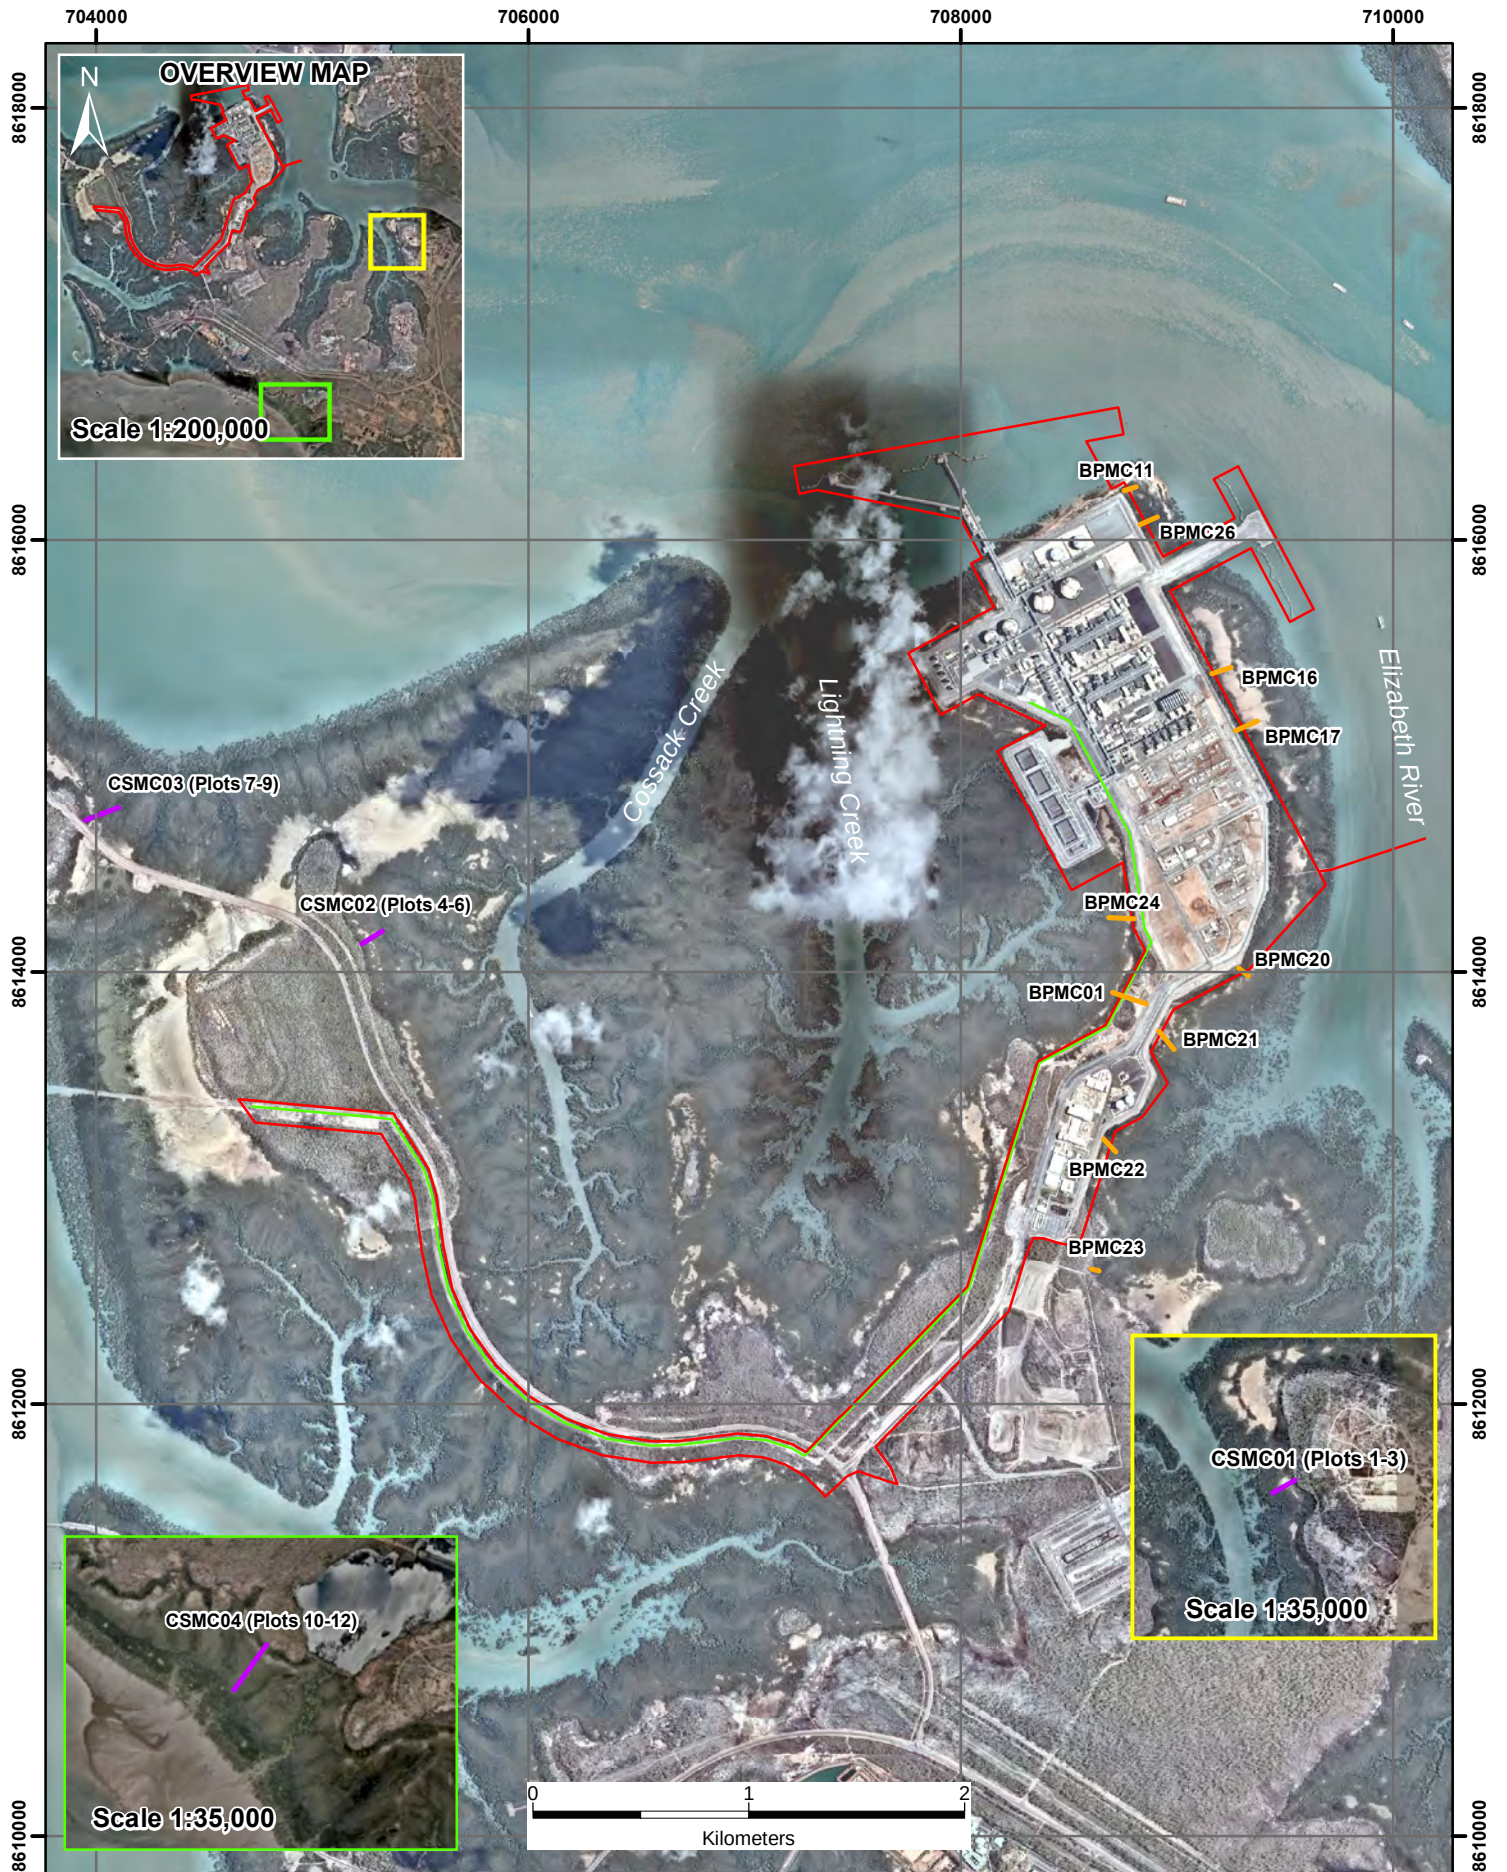
## Mangrove Monitoring Locations

| Figure 4-9 | Mangrove Monitoring Locations ..... | 4-22 |

Mangrove monitoring occurred at the locations identified on **Figure 4-9**.
